NATIONAL CITY
**GRANGER
MUSIC HALL**

RELOCATION FEASIBILITY STUDY

November
7, 2017

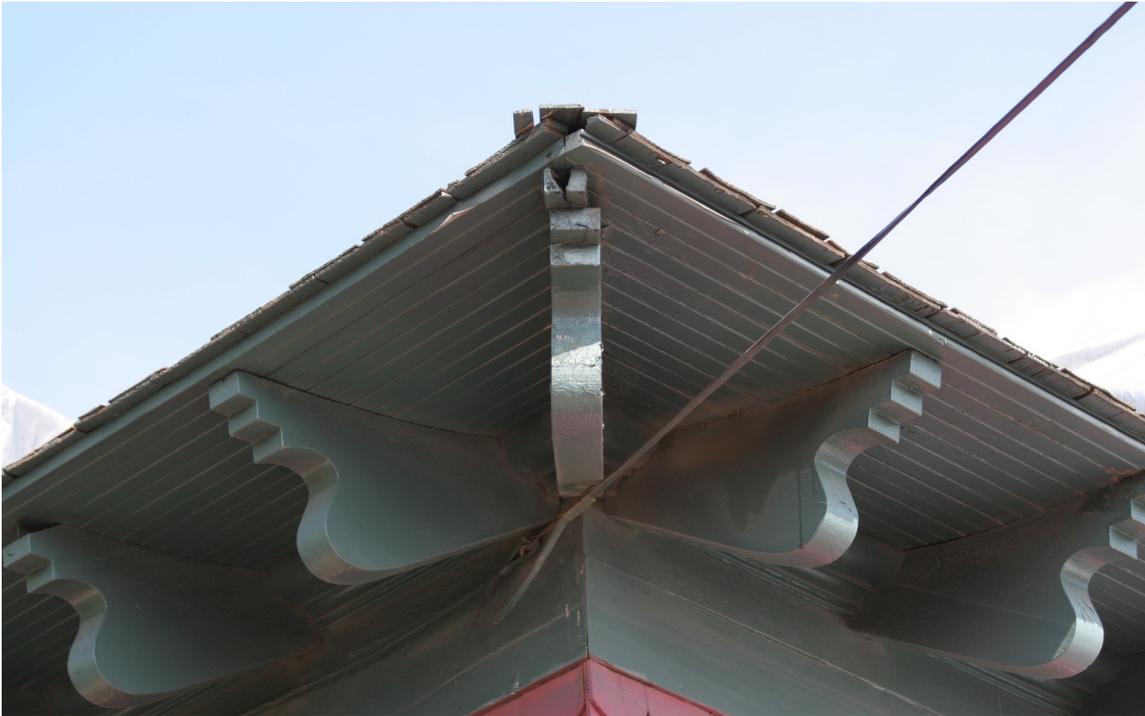
The roof features flared eaves with shaped rafter tails and 1x4 V-groove tongue-and-groove sheathing. In general, the rafter tails are in fair condition. The exposed sheathing at the eaves is in fair condition (refer to Figure 5 and Photos 13 & 14). The attic space was not accessible for inspection.

Figure 5: Typical eave condition showing the V-groove tongue-and-groove sheathing and elaborately shaped rafter tails, 2010.

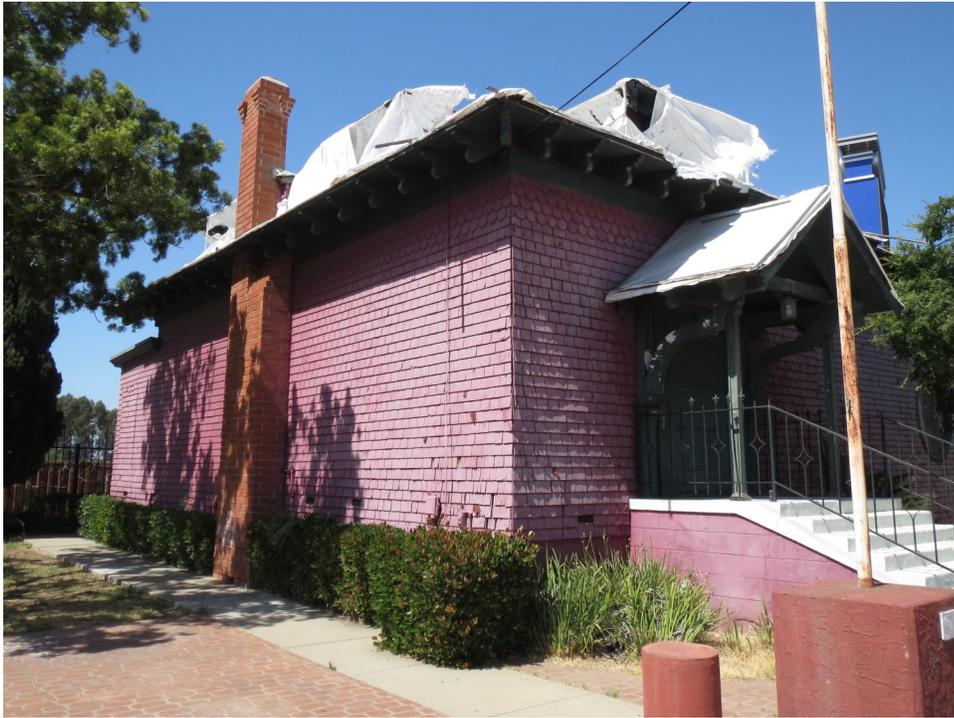
Photo 5: Southwest corner. Note the damaged roof tarp and the brick chimney, 2017.

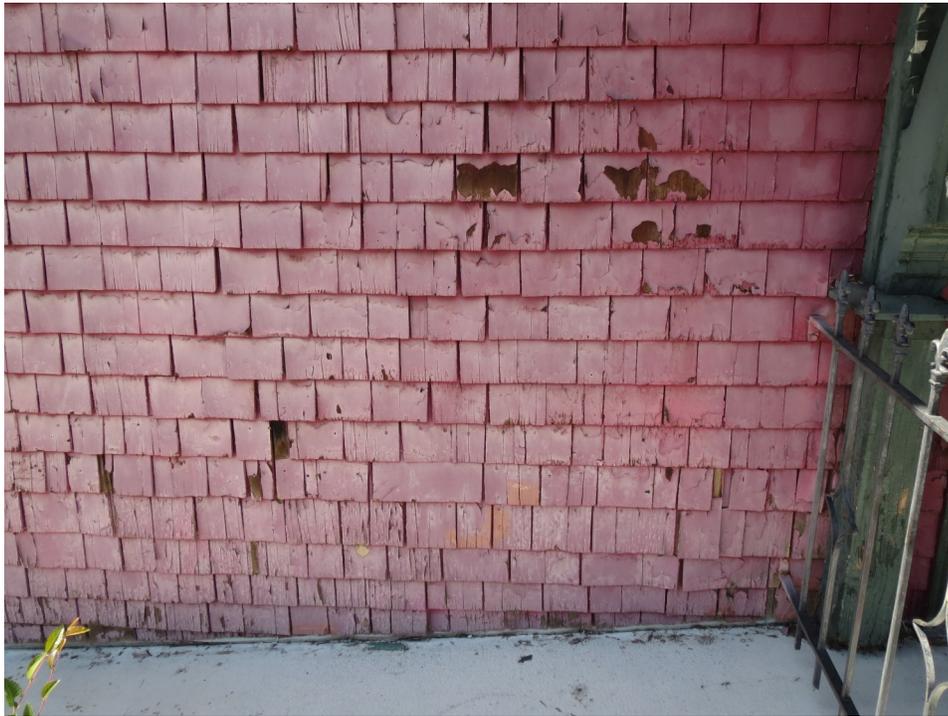
The paint is in poor condition with significant fading, chalking, flaking, and deterioration. The existing color scheme is red walls with green trim. Preliminary paint scraping revealed that the first visible paint layer is similar in color to the current paint although there appears to be a minor variation in the original hues. A detailed microscopic paint investigation should be used to determine the exact color of the original paints so the historic scheme can be replicated (refer to Photos 11 & 12).

The exterior walls are finished with wood shingles. The shingles are 11 ½-inches long with square cut ends set with a 4 ½-inch exposure. The top four rows of shingles have rounded ends with approximately the same exposure. The general condition of the shingles is fair to poor with significant paint deterioration and many split or displaced shingles (refer to Photos 11 & 12).

Photo 11: Example of the damaged paint and wood shingle siding adjacent to the wheelchair ramp, 2017.

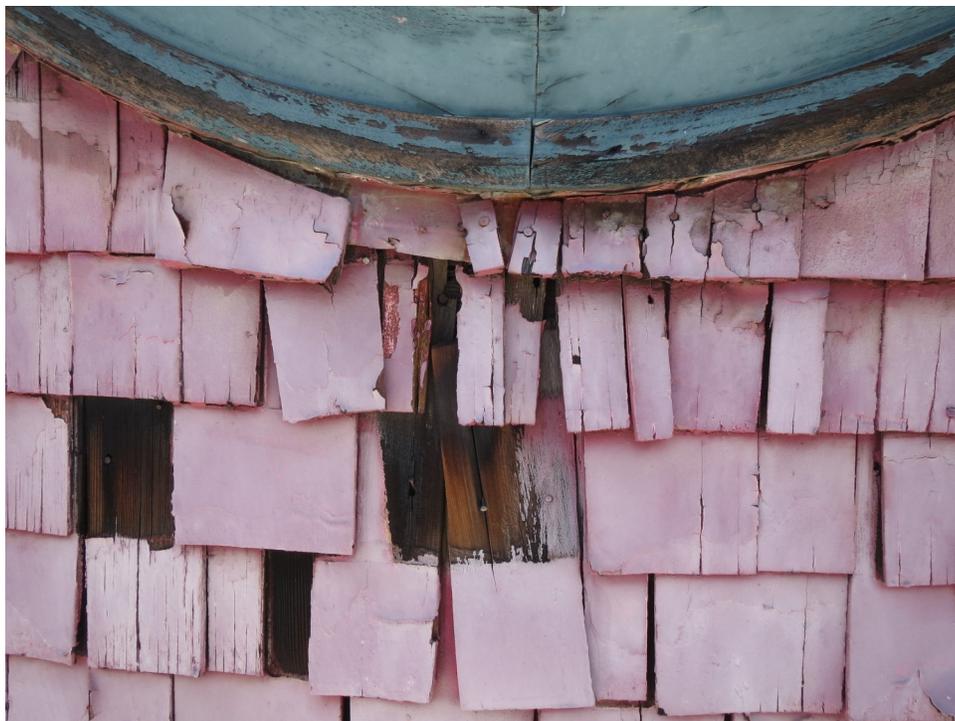
Photo 12: Close-up of damaged shingle siding on the south façade, 2017.

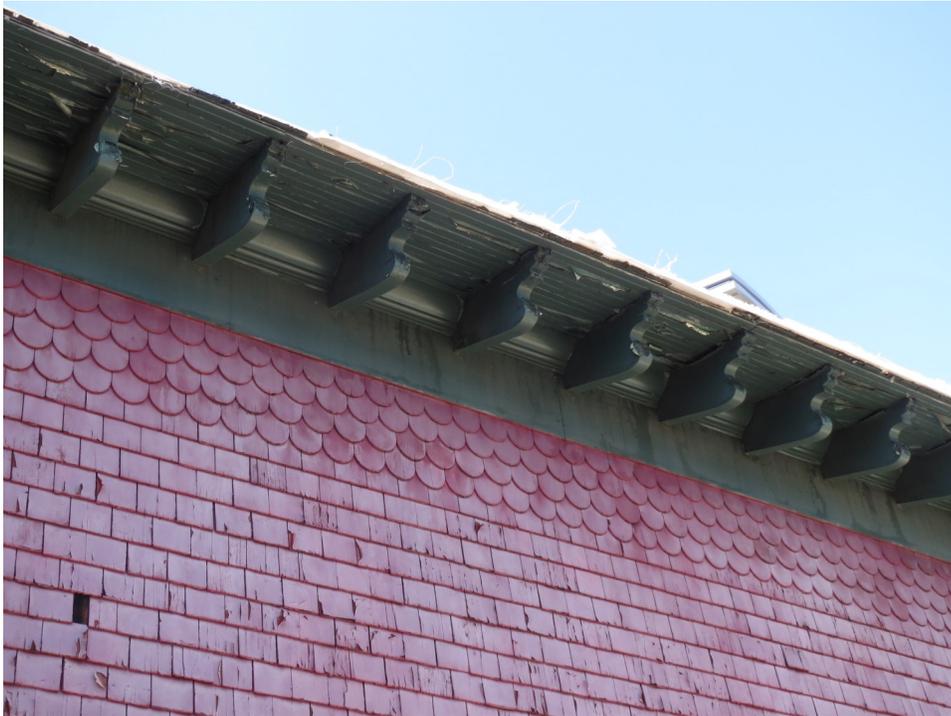
Photo 13: Upper south wall showing the fish scale shingles and roof eave, 2017.

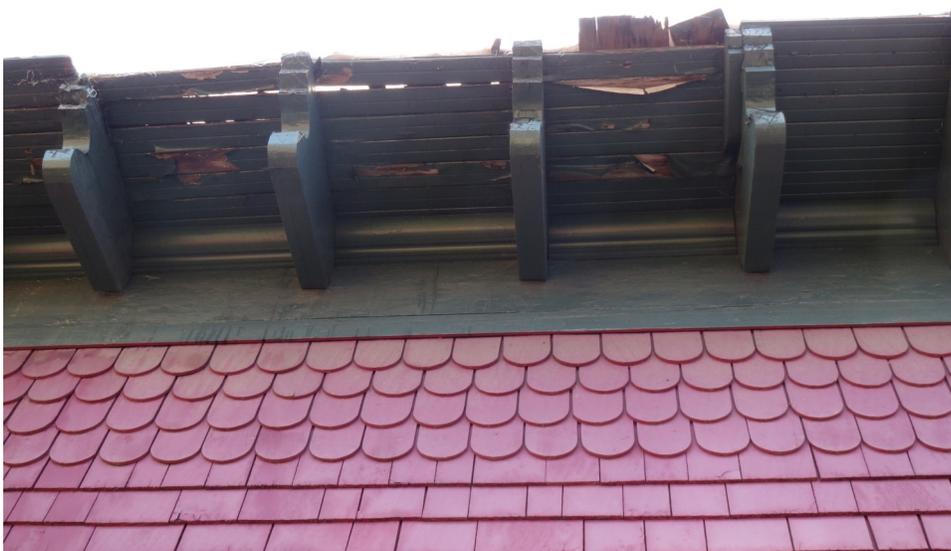
Photo 14: Damaged roof eave boards and shaped rafter tails, 2017.

“pick points.” The rafter tails appear to be in fair to good condition, an assumed 30% replacement would likely be adequate for budgeting.

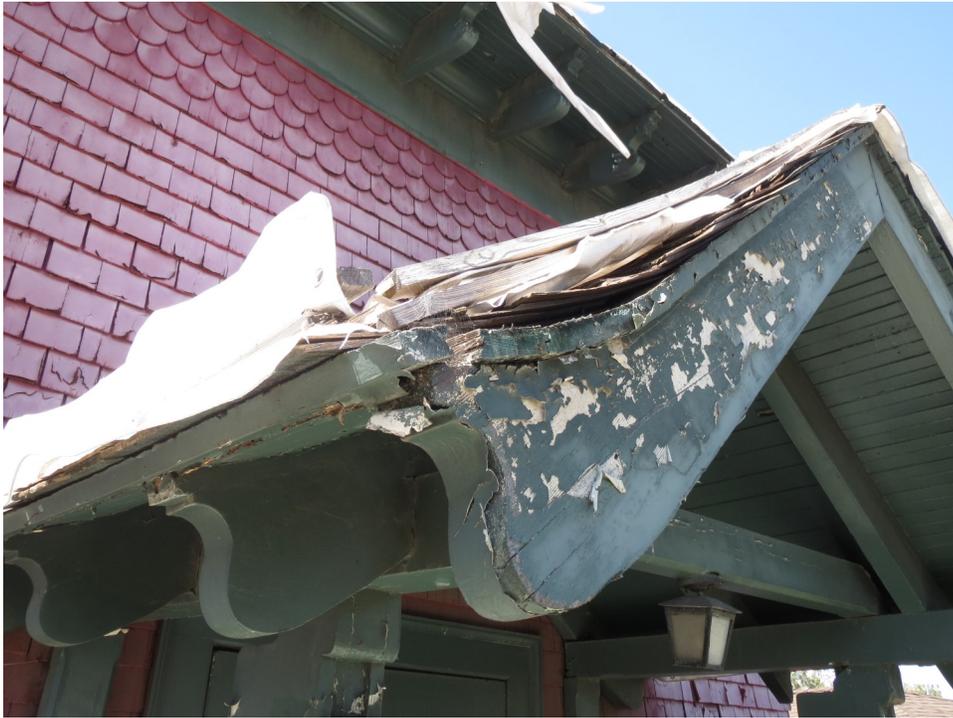
There are two historic porches on the south wall of the building. Both porches have gabled roofs with flared eaves and shaped rafter tails (refer to Figures 2 & 4 and Photos 3 & 15). The west porch roof is in fair condition with some evident of wood deterioration, deteriorated paint, and deteriorated roofing. The east porch roof is in poor condition with significant wood deterioration caused by dryrot and termites (refer to Photos 15 & 16). The front posts of both porches are non-historic. Historic photographs indicate that the porch roofs originally cantilevered without outer posts (refer to Figure H1).

Photo 15: Close-up of the east entry canopy showing the peeling paint and dryrot damage, 2017.

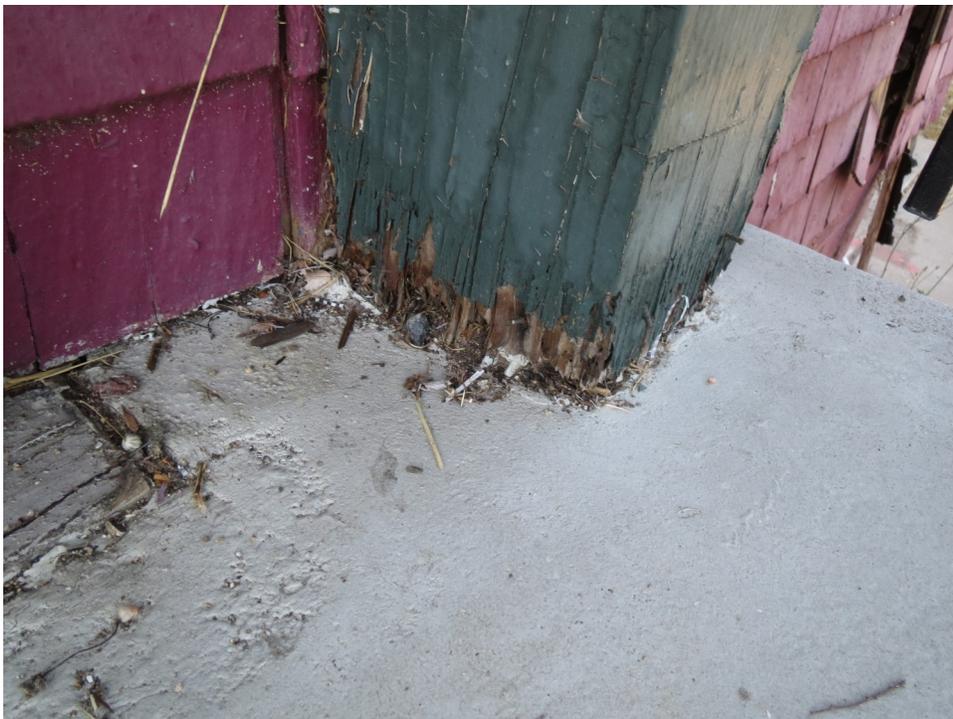
Photo 16: Base of a wood support post at the east canopy showing termite damage, 2017.

A termite inspection and tenting is recommended. Additionally, the City should consider installing an automatic fire sprinkler system throughout Granger Music Hall, being careful not to further damage the historic decorative ceiling.

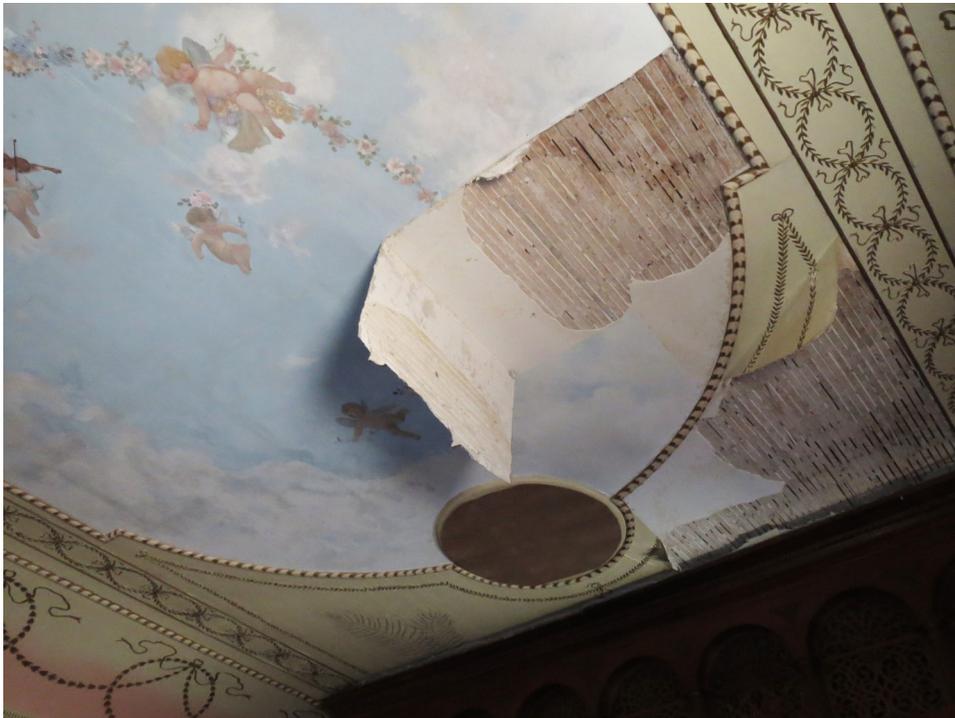
The roof is hipped with a low-to-moderate moderate slope and hipped dormer windows that provide natural light to the interior performance hall along with skylights. The roof is clad with wood shingles. A plastic tarp has been nailed to the roof to temporarily address leaks. The roofing is in poor condition and should be replaced immediately to prevent further damage to the interior finishes. Failure of the temporary roof tarp, installed in 2015, has led to water infiltration and collapse of two areas of the hand-painted ceiling in the Performance Room (refer to Photos 18 & 19). A replacement roof tarp was installed earlier this year.

Photo 18: The east end of the Performance Room ceiling showing severe water damage which has caused areas of plaster to collapse, 2017.

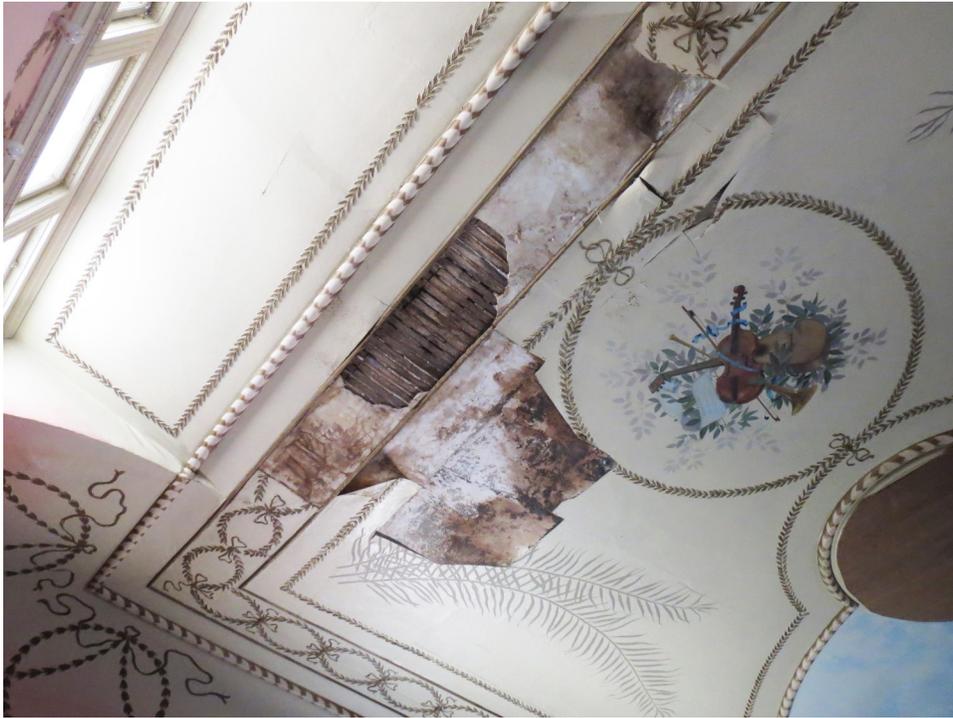
Photo 19: The west end of the Performance Room showing damaged ceiling plaster caused by leaking rain water, 2017.

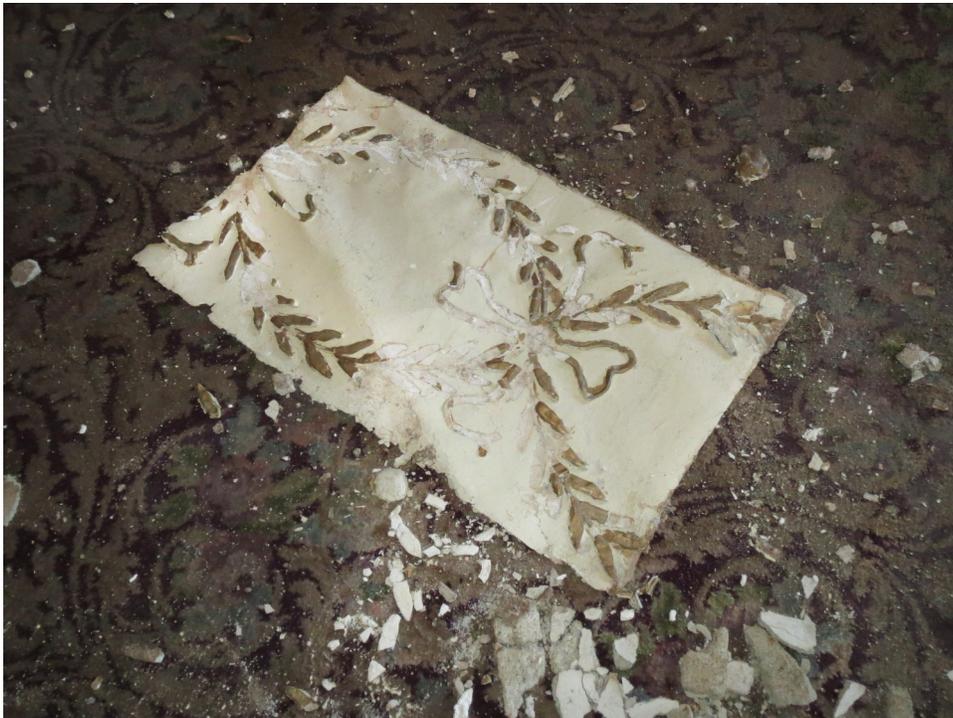
Photo 20: A fallen section of the west ceiling fabric with damaged plaster décor, 2017.

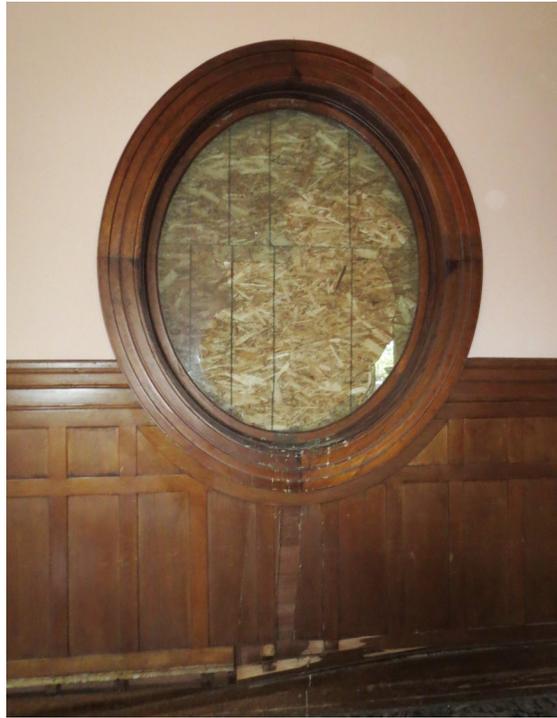
1, 8 & 21). Historic photographs indicate that the windows originally had vertical muntins -- and possibly horizontal too (refer to Figure H1). Although the historic muntins have been removed, the existing wood frames remain in fair to good condition. The northeast circular window was broken by vandals or vagrants since 2010 and the opening has been sealed with plywood.

Photo 21: The northeast circular window which was broken by vandals, 2017.

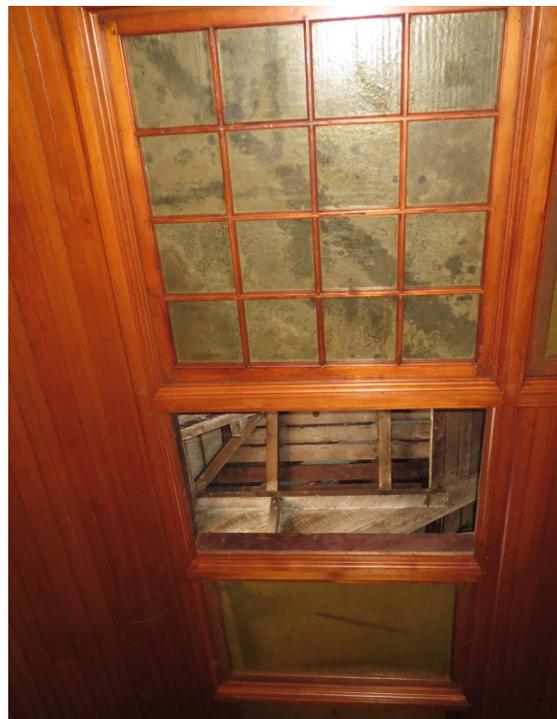
Photo 22: Skylight in the Music Room with a missing panel, 2017.
