NATIONAL CITY
**GRANGER
MUSIC HALL**

RELOCATION FEASIBILITY STUDY

November
7, 2017

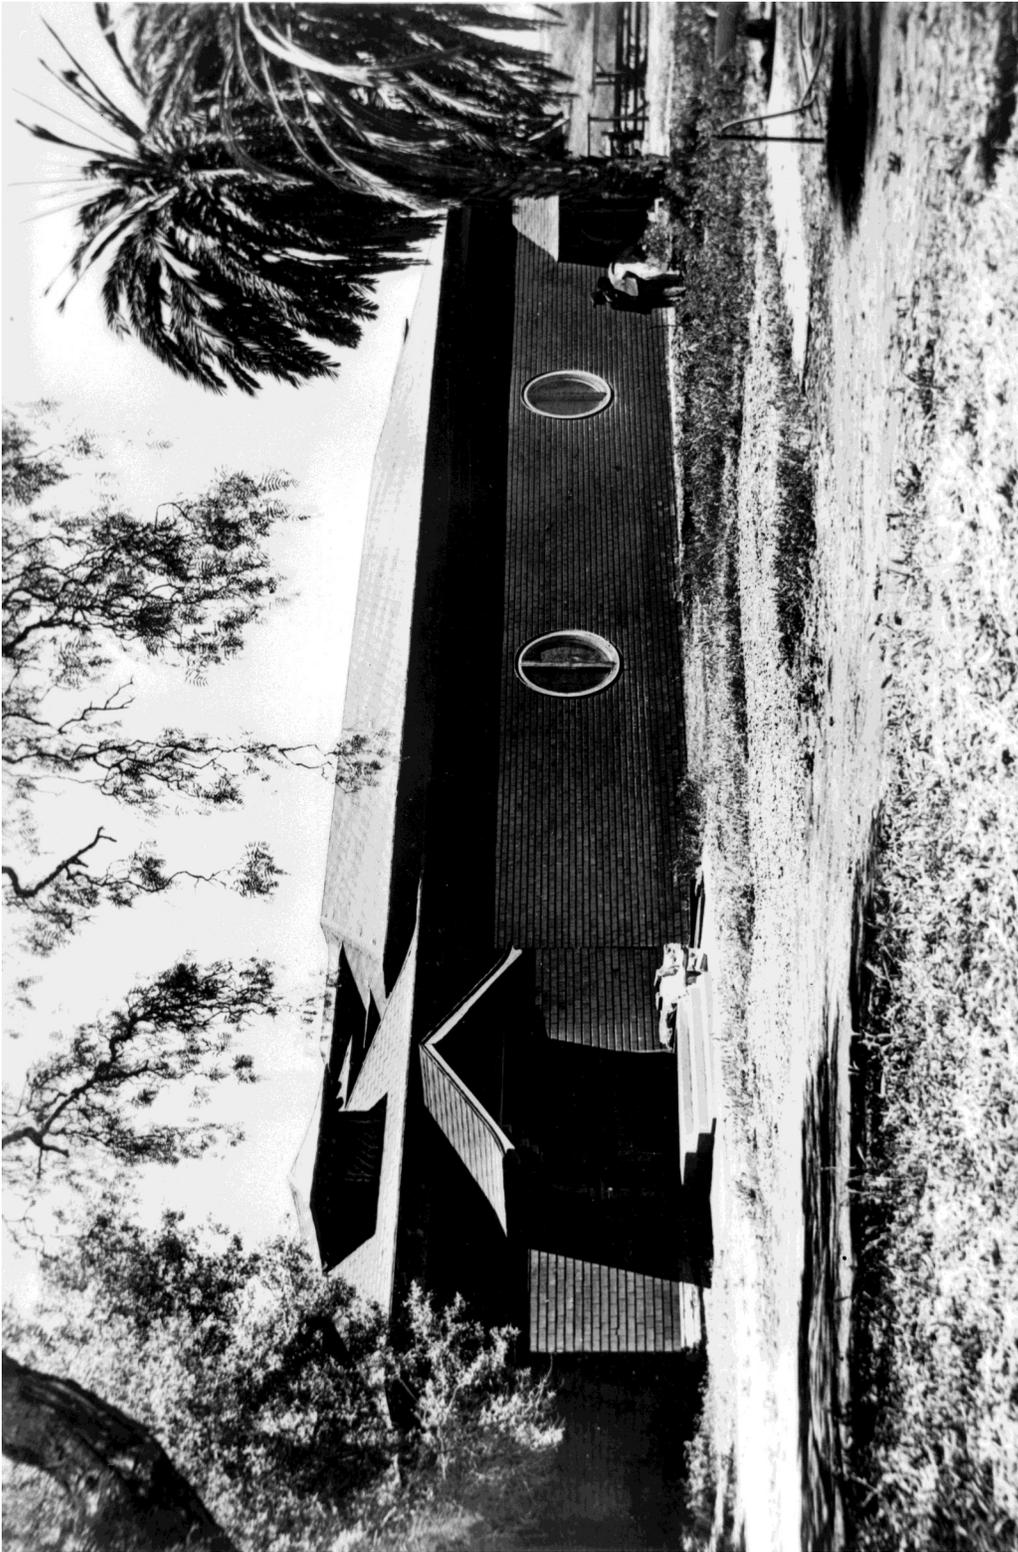
There are two historic porches on the south wall of the building. Both porches have gabled roofs with flared eaves and shaped rafter tails (refer to Figures 2 & 4 and Photos 3 & 15). The west porch roof is in fair condition with some evident of wood deterioration, deteriorated paint, and deteriorated roofing. The east porch roof is in poor condition with significant wood deterioration caused by dryrot and termites (refer to Photos 15 & 16). The front posts of both porches are non-historic. Historic photographs indicate that the porch roofs originally cantilevered without outer posts (refer to Figure H1).

Figure H1: The Granger Hall in its original location. Note the lower height above exterior grade.

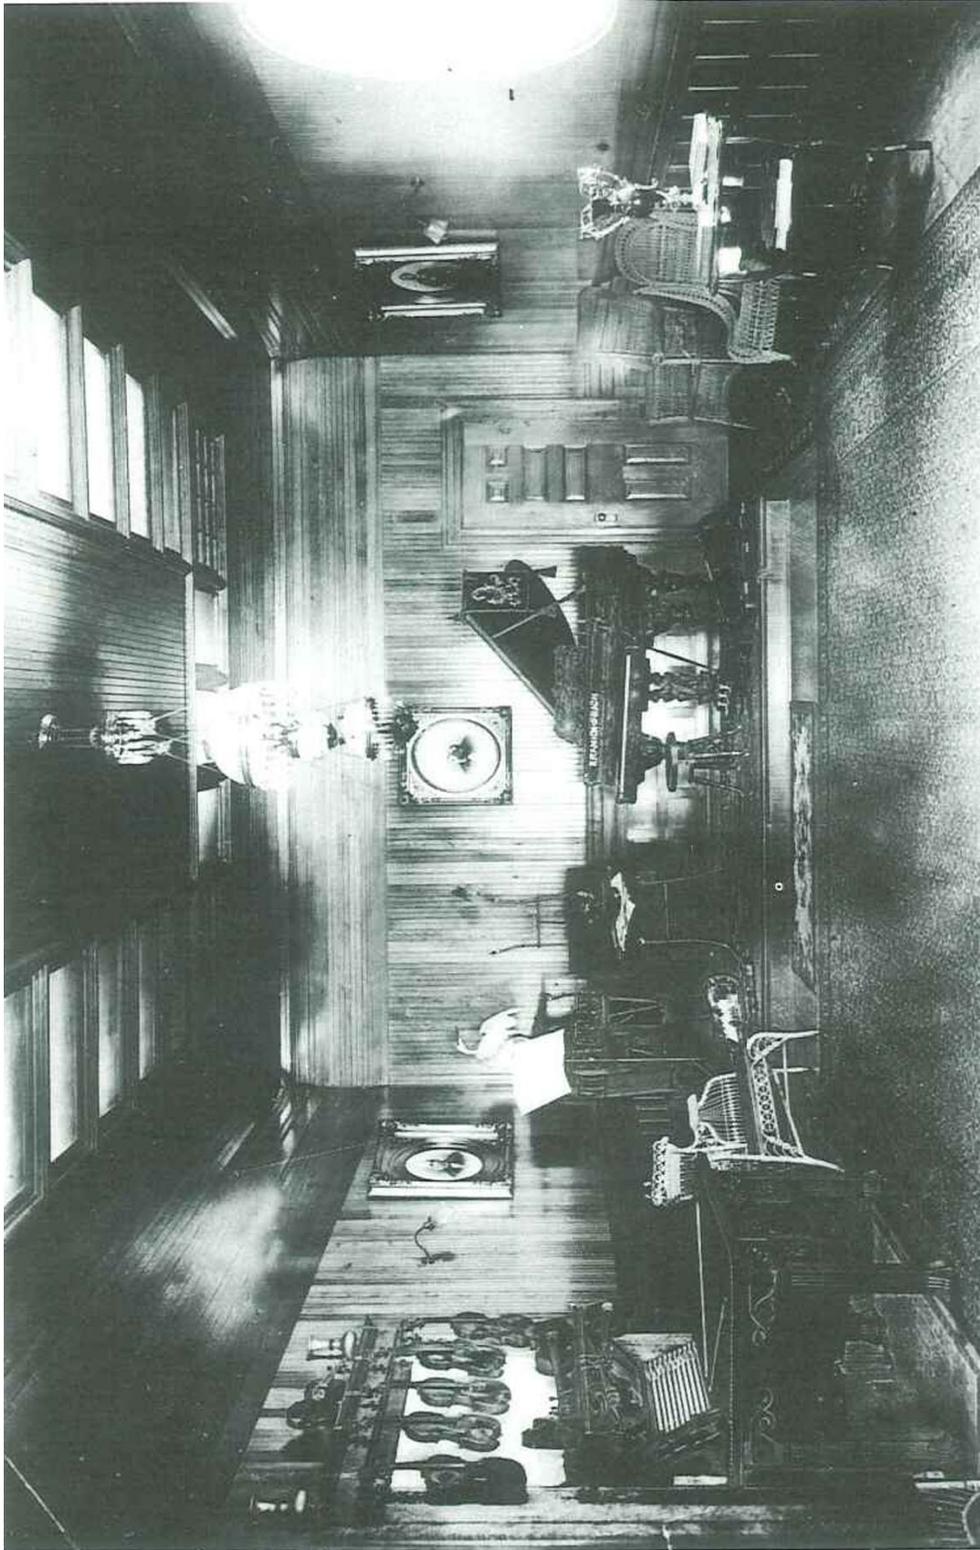
The Storage Room was not accessible at the time of the field assessment, so this report does not include an assessment of the existing interior conditions of this space. The room is not historic. A historic photograph the original Music Room shows that there was no door in the location of the existing door (refer to Figure H2).

Figure H2: The Granger Music Hall Ca. 1896 prior to the 1898 expansion. Note the original stage platform, door locations, wood flooring, lighting, and fireplace mantel. These features have been modified; but the original paneled walls, wood wainscot, skylight, and coved ceiling remain intact.

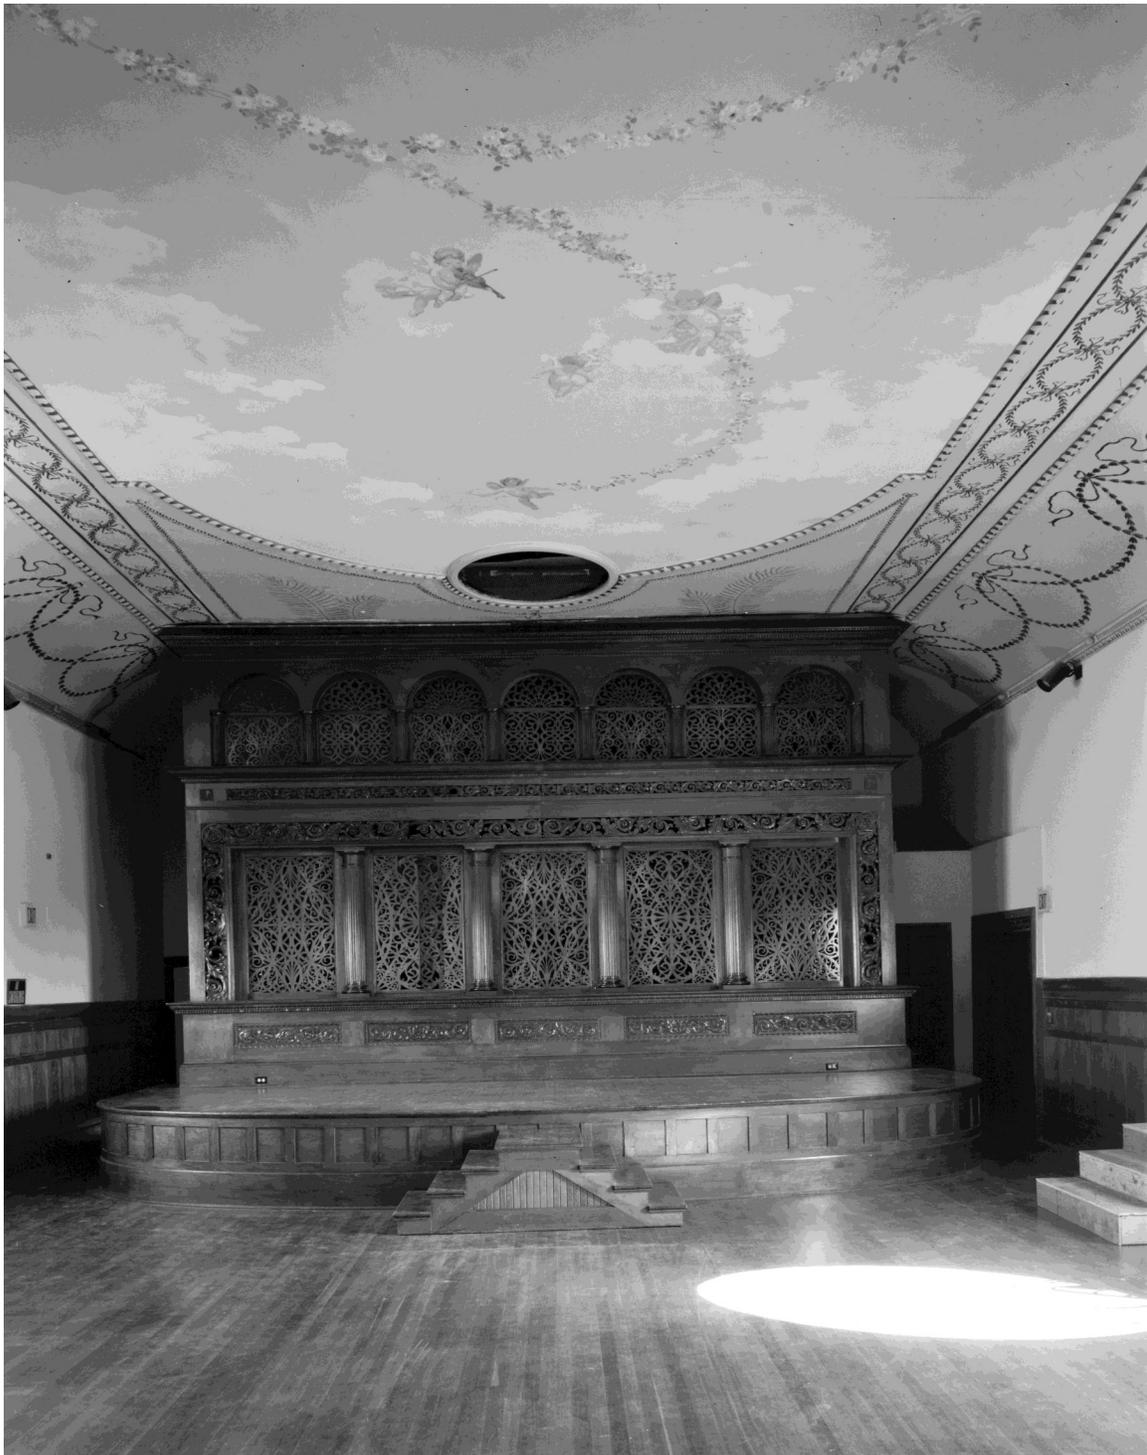
Figure H7: HABS photo (1980) looking east at the stage and organ screen. Note the decorative circular screen in the ceiling has been removed.

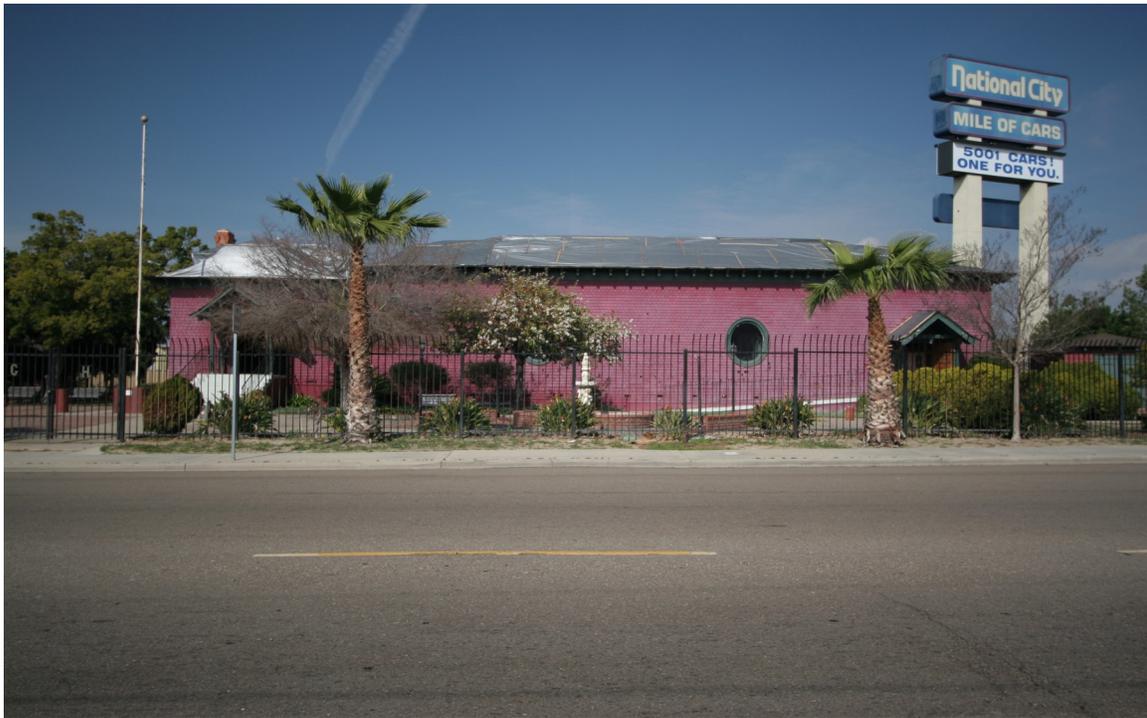
Figure 1: Granger Music Hall looking north, 2010.

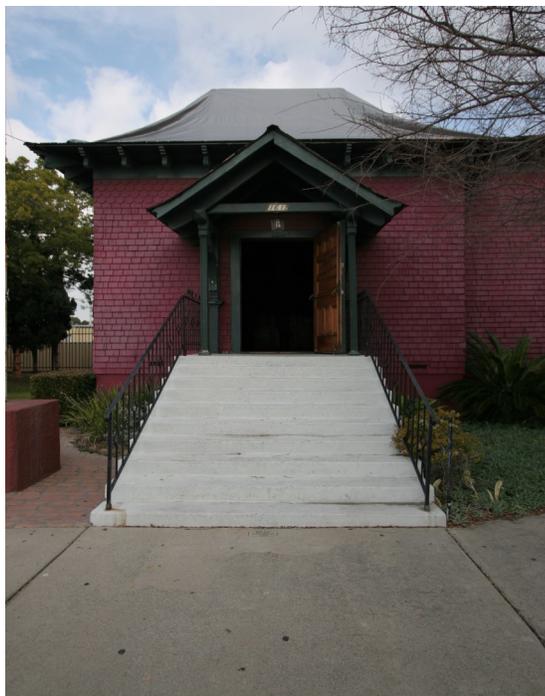
The floor of the west porch, which leads to the older section of the building, is approximately 4'-8" above the exterior finish grade (refer to Figure 2 and Photo 3). The porch floor and steps are concrete. They were added in 1972 when the building was relocated to the current site. The typical rise is 5 3/8-inch. The treads are 12-inches deep. The stair includes a non-historic 1972 metal handrail which does not comply with current code.

Figure 2: Granger Hall in 2010 looking north at the main entry showing the historic porch roof, non-historic concrete steps, and non-historic metal railings. The building was raised approximately 30 inches when it was relocated in 1972.

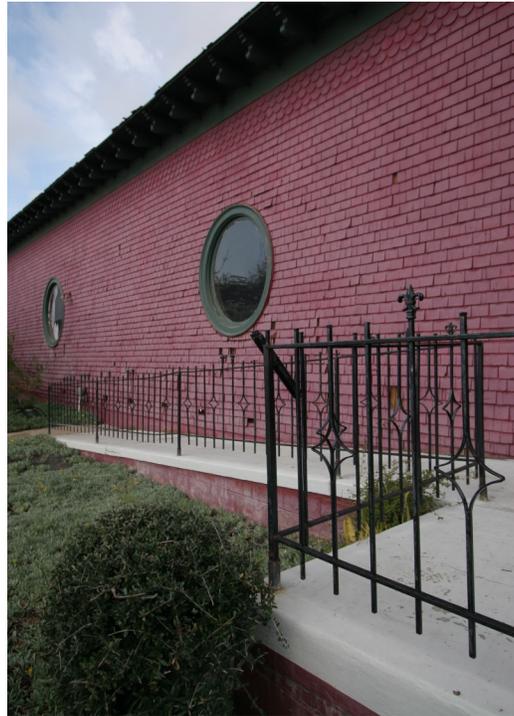
There is a 1972 concrete ramp and landing at the east porch which leads to the Performance Room (refer to Figure 3 and Photo 1). The landing is 2'-9" above the exterior finish grade. The difference in elevation between the two porches accommodates the interior level change between the two main rooms. The 1972 porch ramp is approximately 30-feet long. It does not comply with current code due to the non-compliant slope, cross-slope, metal handrails, and landing dimensions. The door thresholds at both entry doors are not code-compliant and include a level change of approximately 1 ½-inches.

Figure 3: Granger Hall in 2010 looking northwest at the non-historic concrete ramp to the main Performance Room entry.

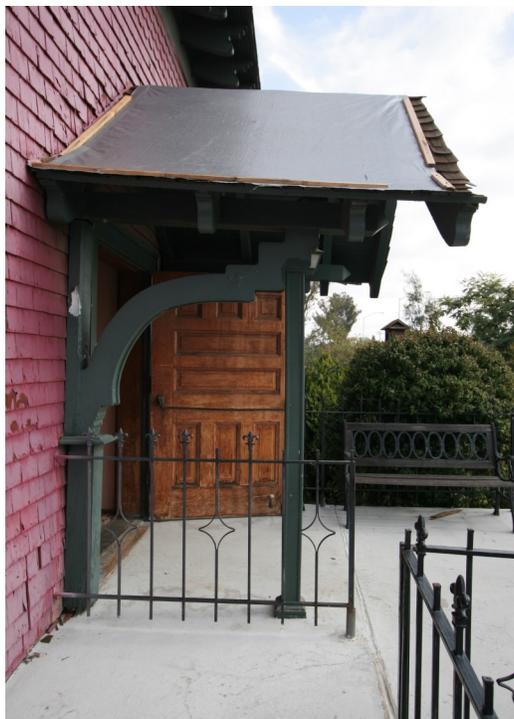
Figure 4: Granger Hall in 2010 looking east at one of the historic porch roofs. The front columns have been added and the porch landing and metal handrails are non-historic.

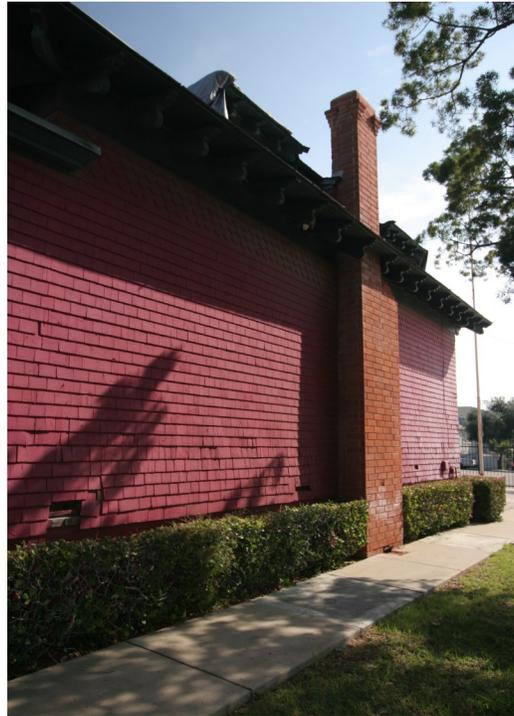
The existing chimney is non-historic, it was reconstructed from oversized non-historic 11 1/2" x 3 1/2" x 3" brick in 1972 when the building was relocated (refer to Figure 7).

Figure 7: Granger Hall in 2010 looking southeast at the non-historic chimney. The location is historic, but the construction is ca. 1972 dating to the previous relocation.

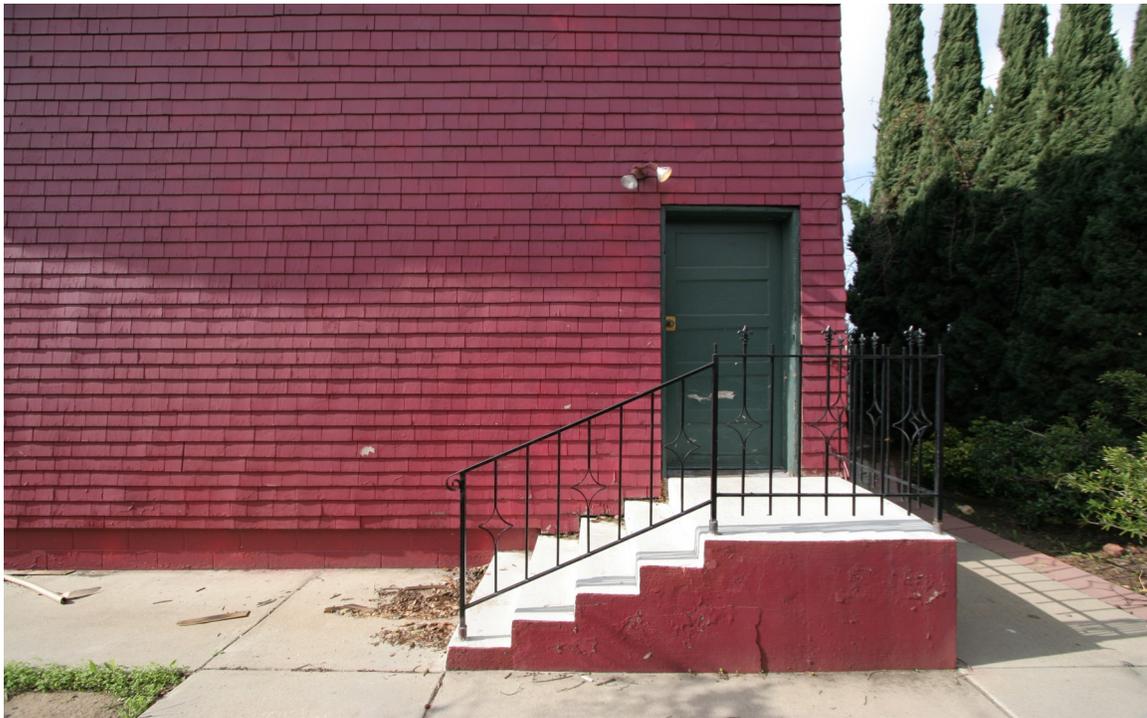
Figure 9: Granger Hall in 2010 looking west at the rear entry. The concrete steps and metal handrail are non-historic.

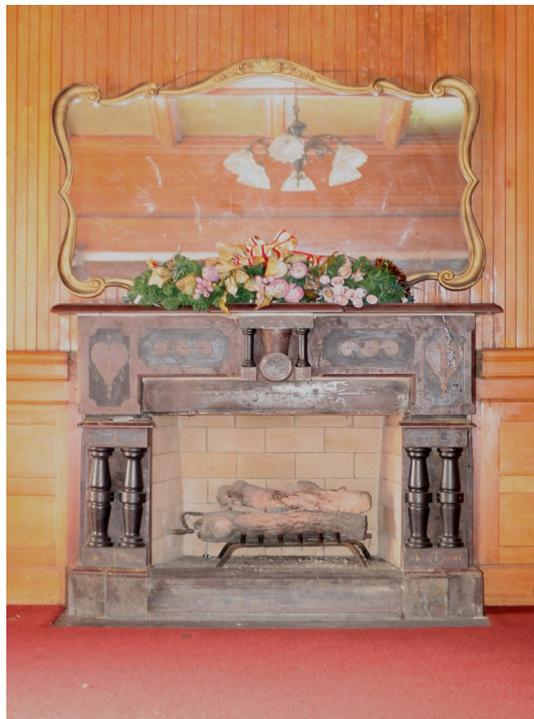
Figure 16: The 1896 Music Room looking west at the fireplace in 2010. The mantel is historic (probably salvaged from another historic building), but it is not original to this building. It was likely installed after the 1972 relocation.

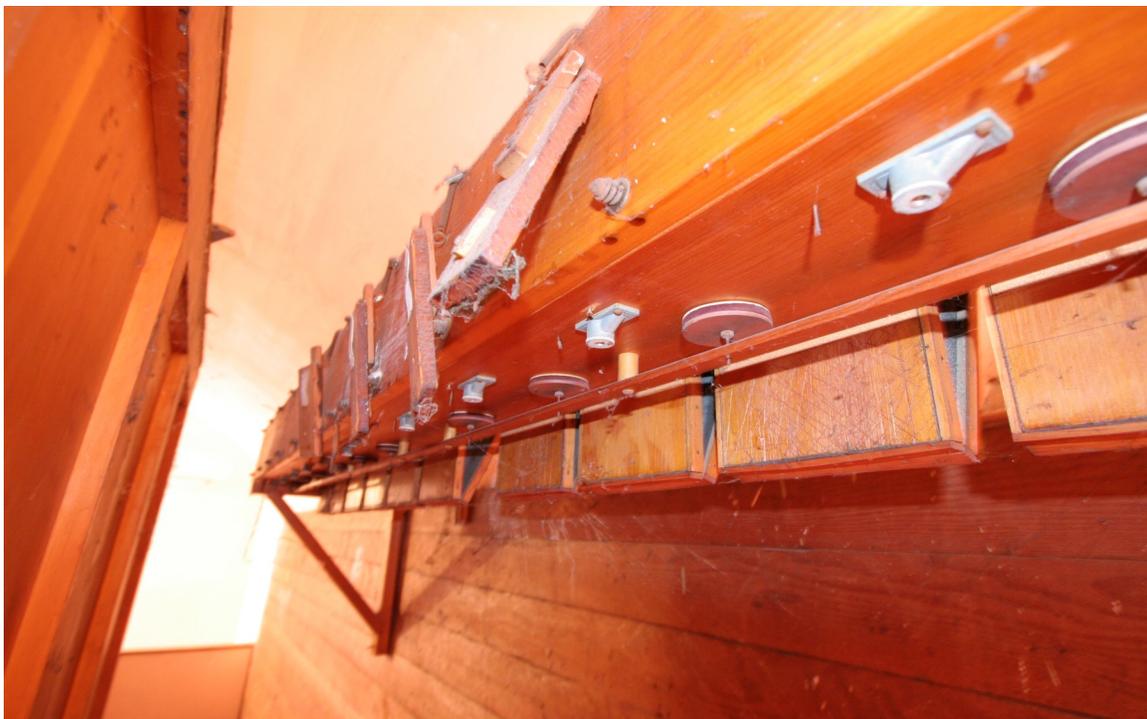
Figure 30: The backstage area showing remnants of the historic organ, 2010.

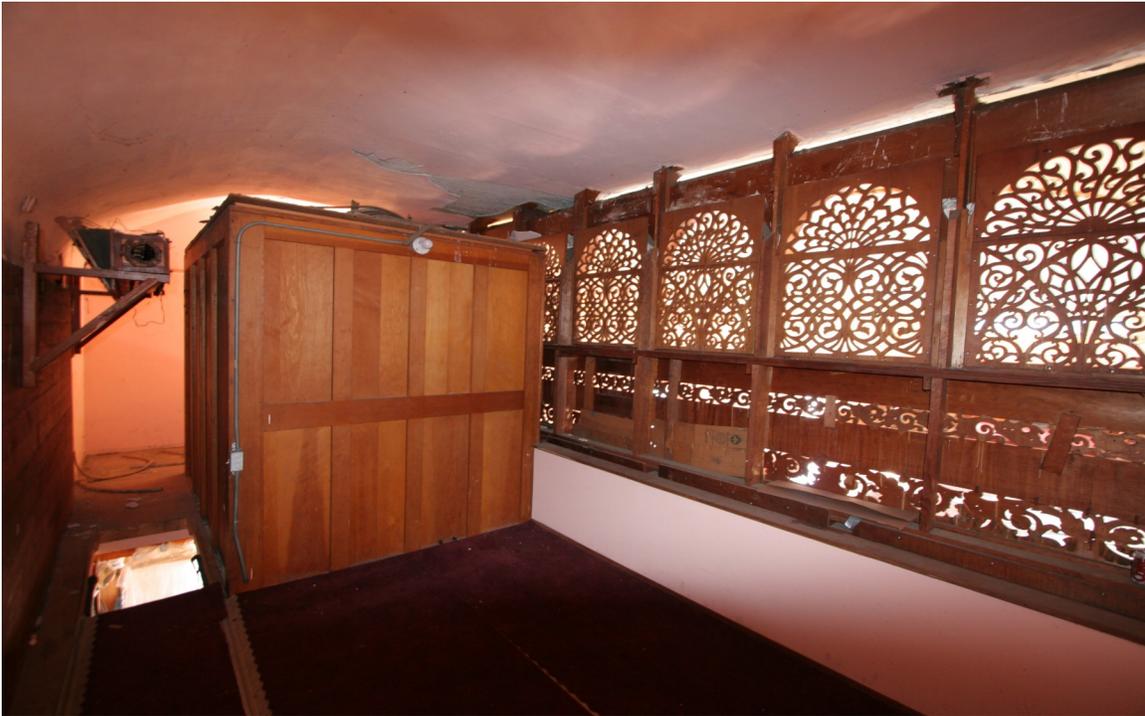
Figure 31: The organ loft looking southwest toward the wood organ screen, 2010.

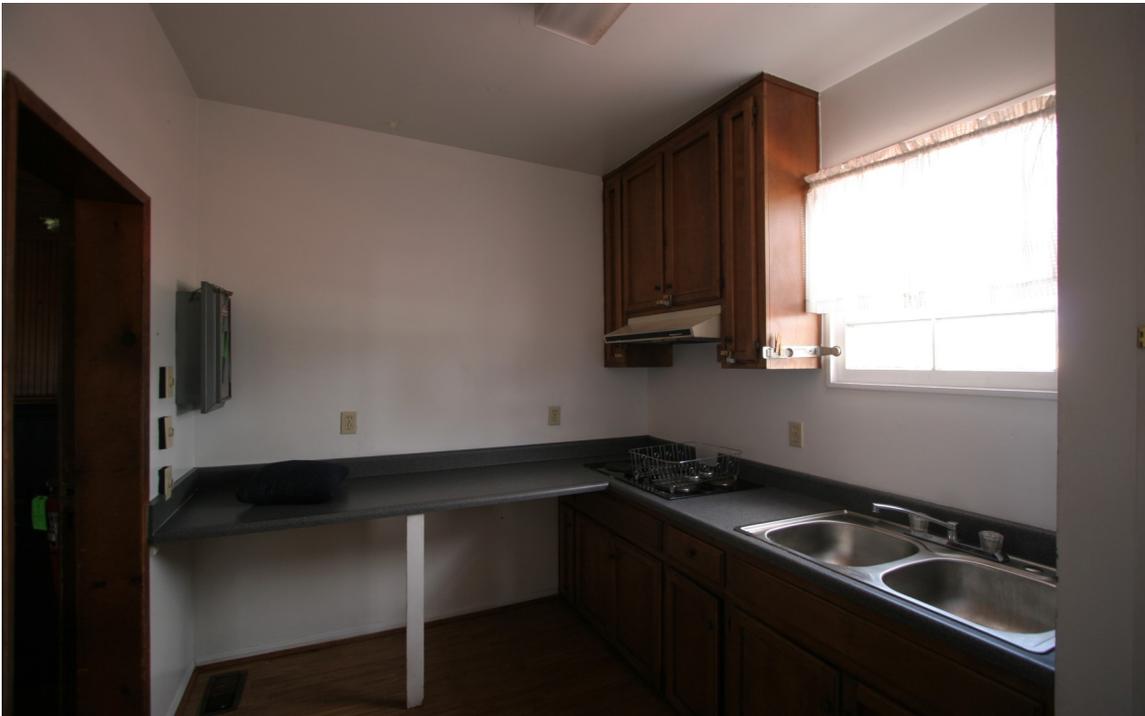
Figure 32: The non-historic kitchen, 2010.

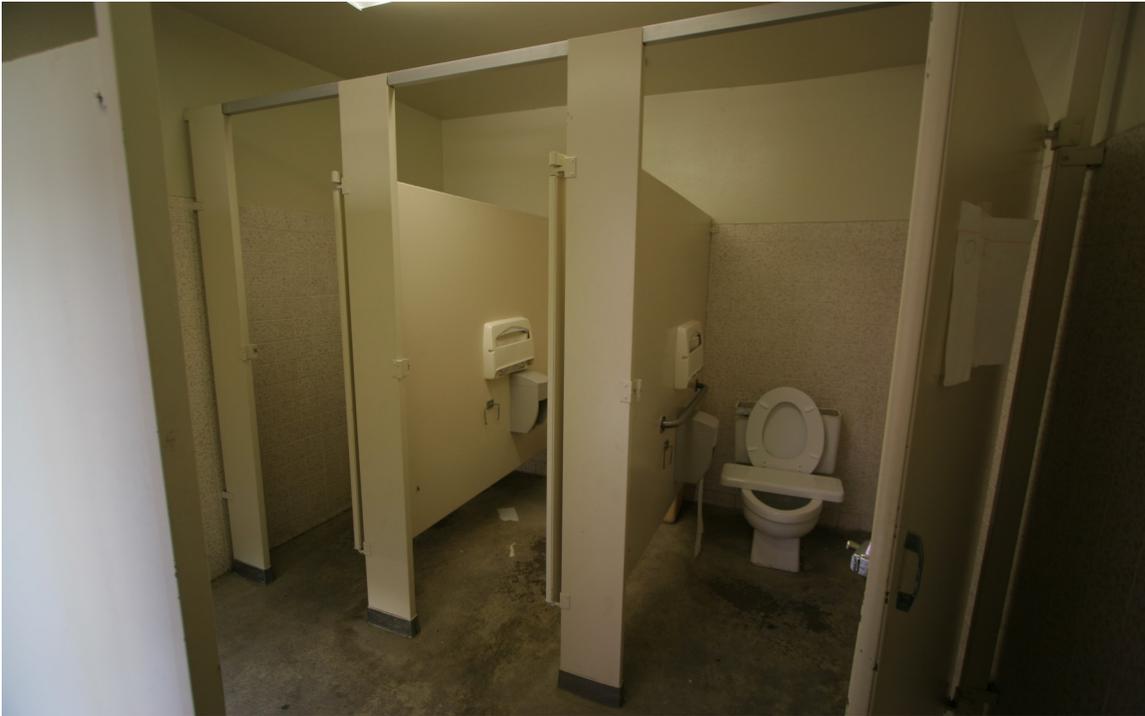
The existing restrooms are non-historic. They are located on the north side of the building in a non-historic (1972) concrete block addition that is accessed directly from the exterior (refer to Figure 8). The existing roof is a low-slope shed roof. The interior finishes include concrete floors, a 5'-8" high ceramic tile wainscot on all interior walls, floor-mounted metal toilet partitions, and painted gypsum board upper walls and ceilings. The women's restroom includes three toilet stalls and one pedestal-style lavatory (refer to Figure 33). The men's restroom includes one urinal, two toilet stalls, and one pedestal-style lavatory (refer to Figure 34). One toilet stall in each room is larger (3'-3" wide by 5'-1" deep) and equipped with side-mounted grab bars. Despite this, the existing facilities do not comply with current accessibility standards. The existing finishes and fixtures are generally in poor condition.

Figure 33: The non-historic women's restroom in 2010. The existing stalls and fixtures do not comply with current accessibility standards.

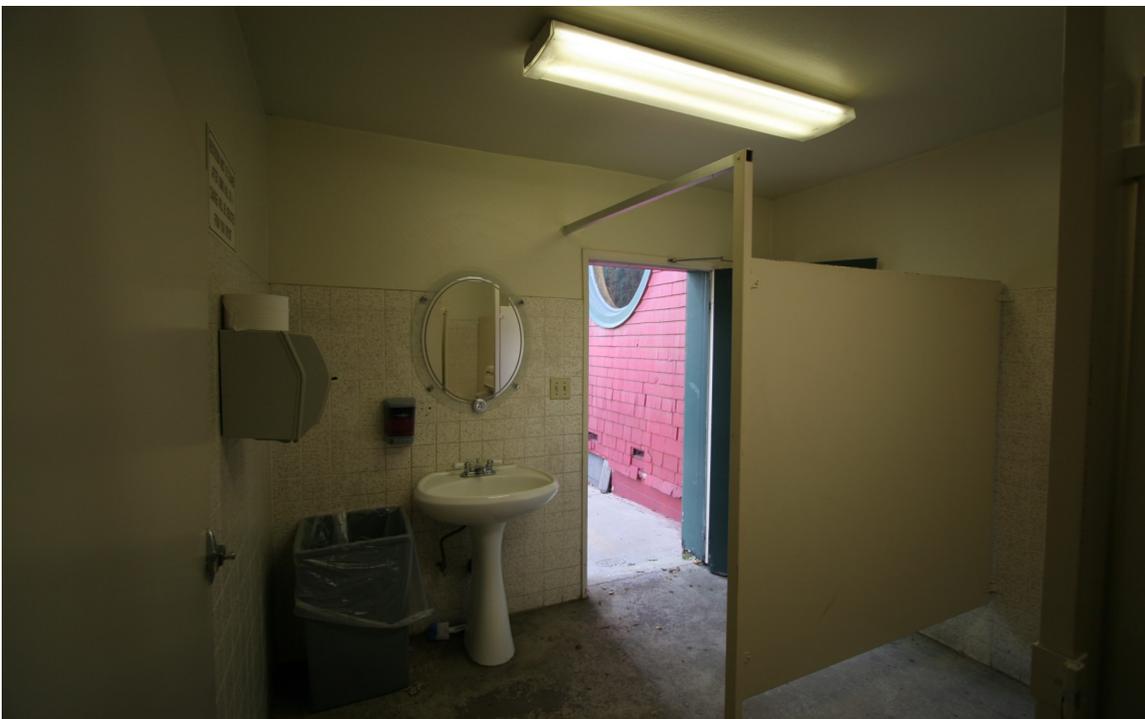
Figure 34: The non-historic men's restroom looking east at the lavatory and partitions, 2010.

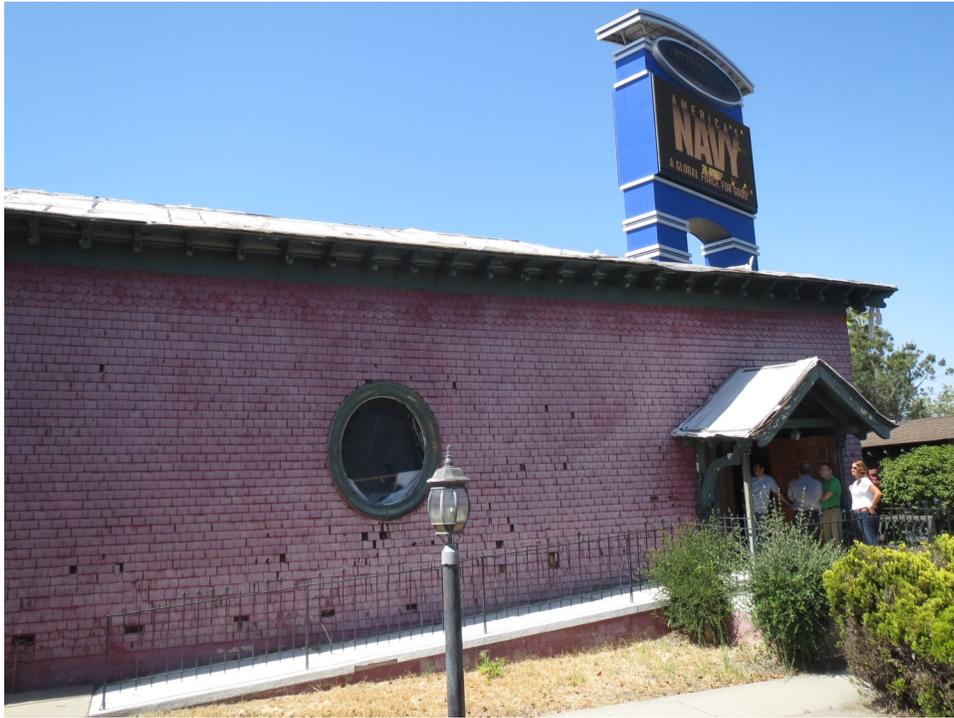
Photo 1: May 2017 view of the east portion of the front (south) façade.

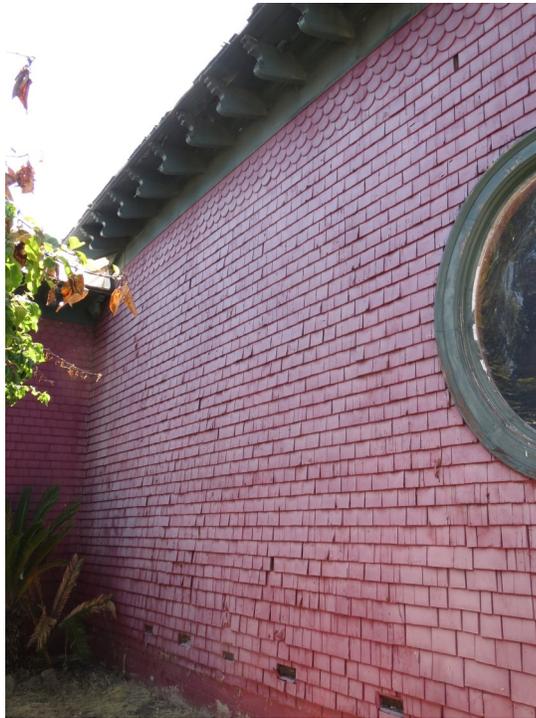
Photo 2: West end of the Performance Room on the south façade, 2017.

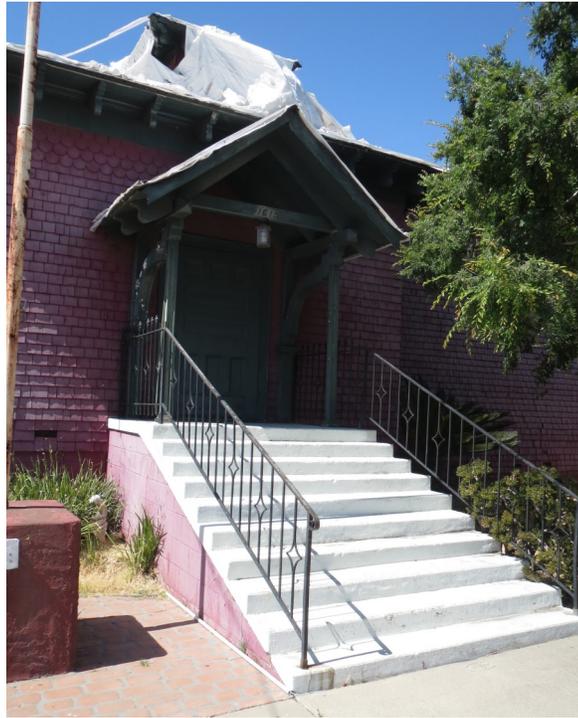
Photo 3: Main entry to the Music Room, looking north, 2017.

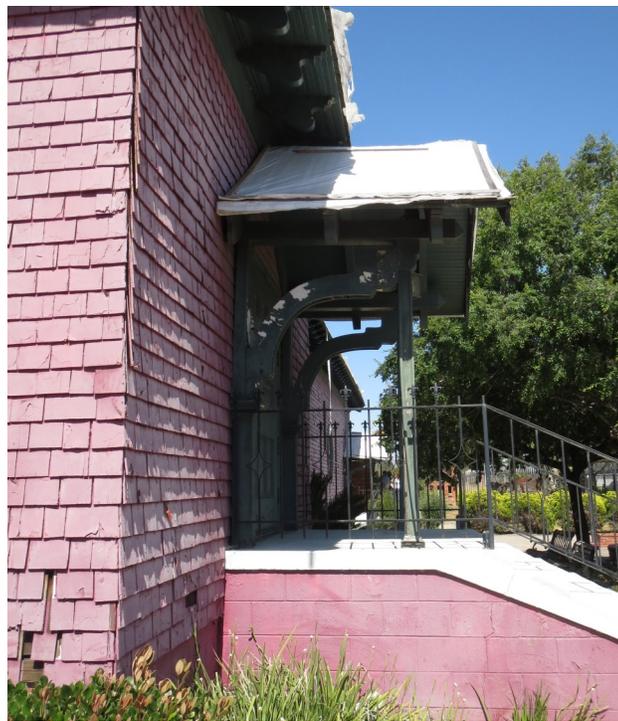
Photo 4: West side view of the Music Room entry canopy, 2017.

The existing porch roofs are in fair to poor condition. The non-historic front posts (2 per porch) should be removed to match the historic appearance. It is likely that additional anchoring and structural support will be required to facilitate the original cantilever. The existing porch platforms, steps, ramp, and handrails are non-historic and will require replacement and reconfiguration for the relocation.

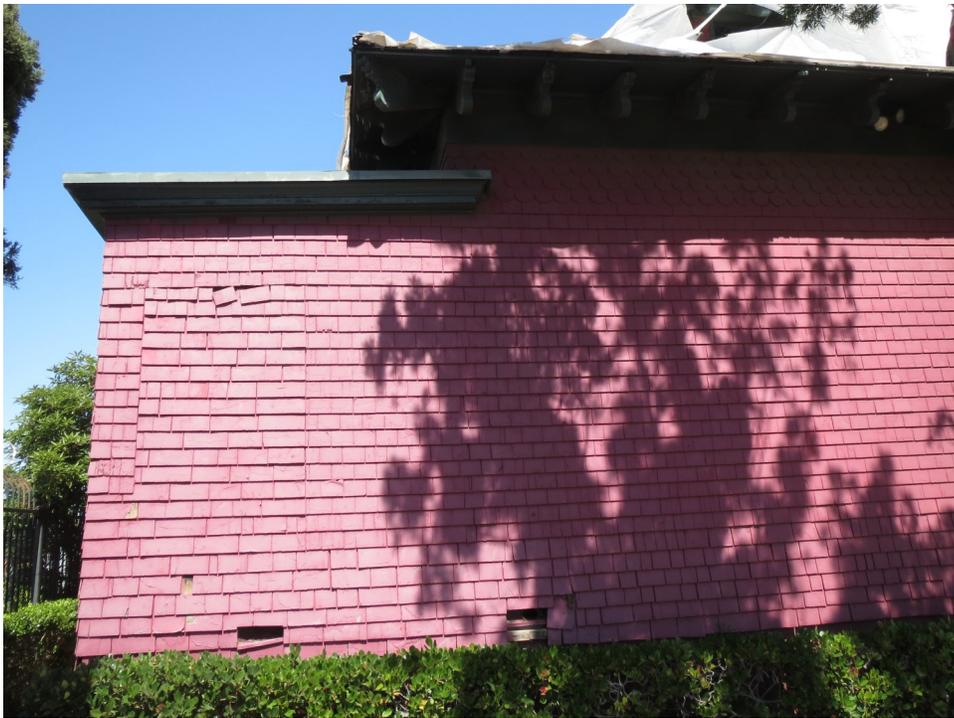
Photo 6: West façade showing the Music Room and Office/Kitchen addition, 2017.

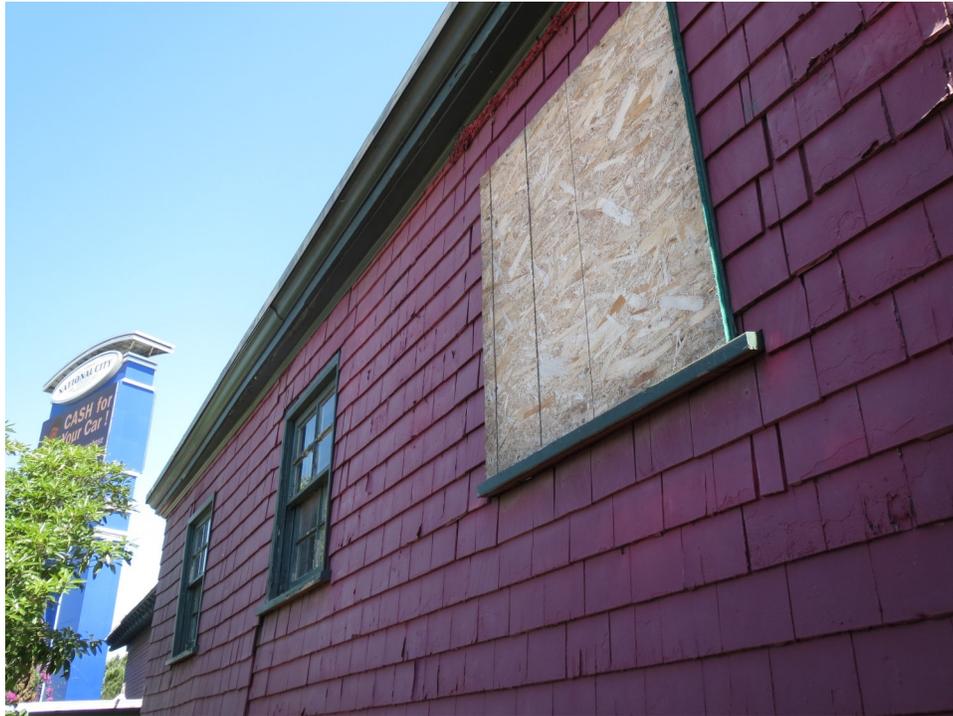
Photo 7: North wall of the Music Room, 2017. Note the boarded-up window.

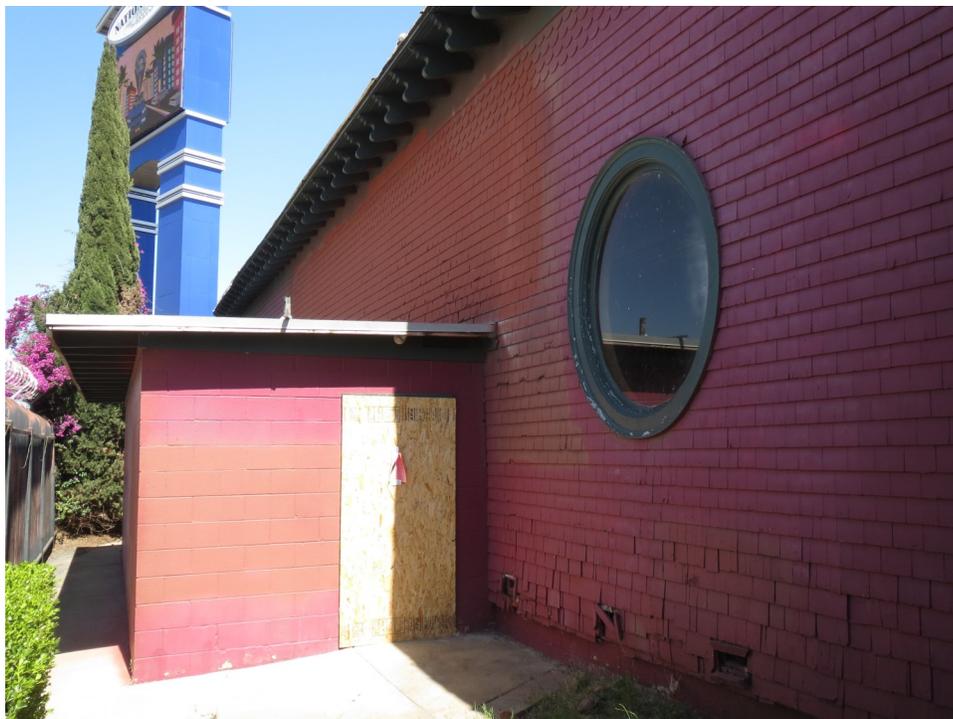
Photo 8: Northwest circular window and the non-historic restroom addition, looking southeast, 2017.

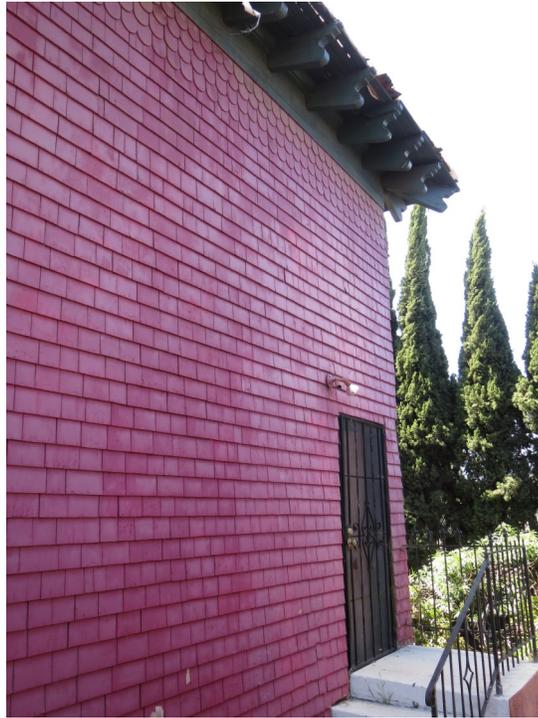
Photo 9: Partial east façade showing the side exit and stair, 2017.

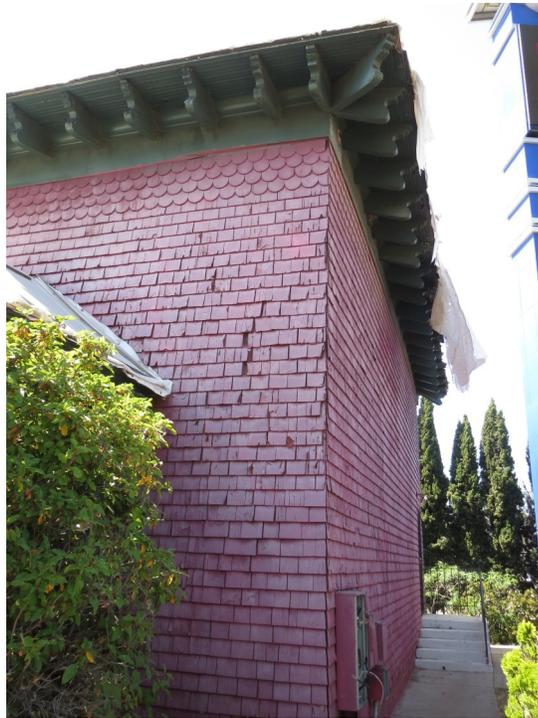
Photo 10: Southeast corner, looking north, 2017.

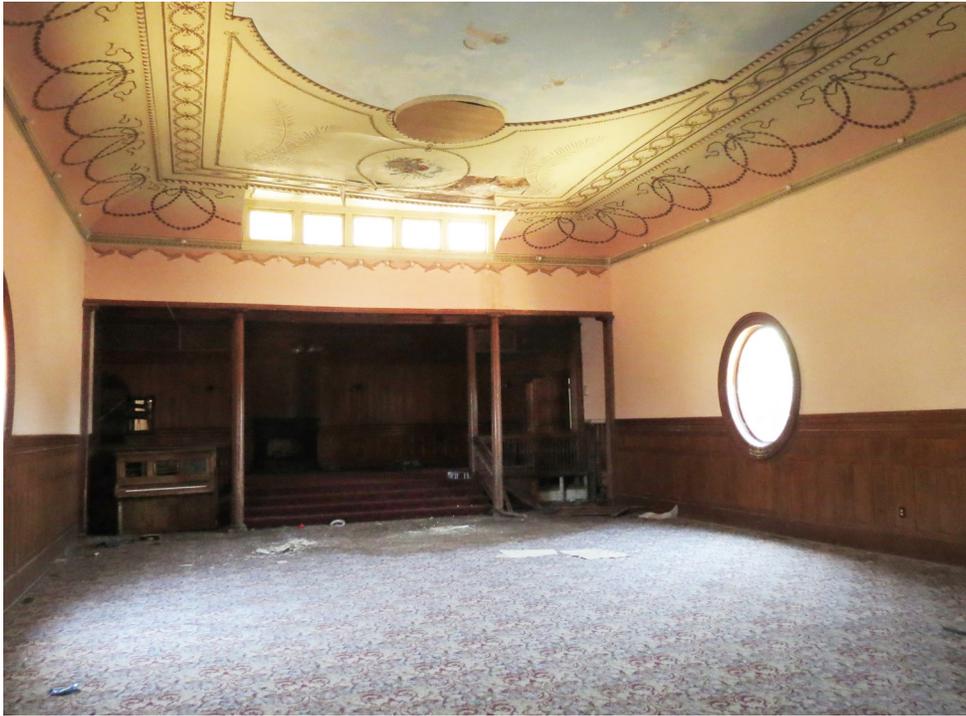
Photo 17: The Performance Room, looking west, 2017.

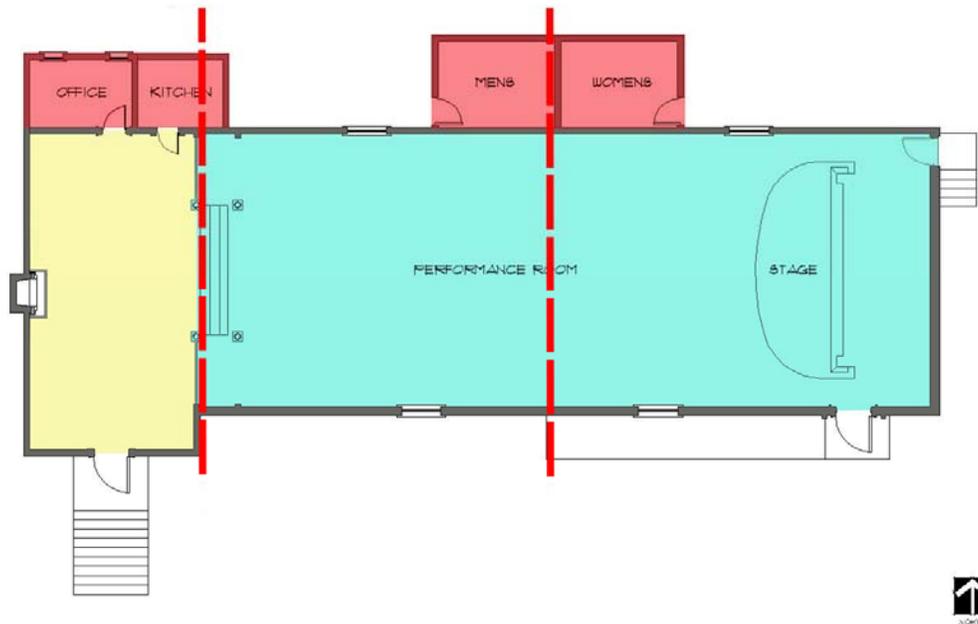
The relocation of the Granger Music Hall will require cutting the building into three pieces. The building will be cut at the joint between the 1896 section and the 1898 addition and also at the center of the Performance Room. When the building was previously relocated, it is assumed that it was also cut at the joint between the 1896 and 1898 portions. The cut will require removal of the existing; wood handrail, ceiling sheathing, and wainscot (refer to Figures 18 and 19). These items should be carefully removed and cataloged so they can be reinstalled after the relocation. The existing steps appear to be non-historic (they are entirely clad in carpet). New steps should be constructed in wood to match the flooring. Additional work will include re-roofing and replacement of exterior shingles at the cut locations.

In the plan above, the dashed red lines indicate the proposed cuts for the move and the red shaded areas indicate non-historic additions to be removed.

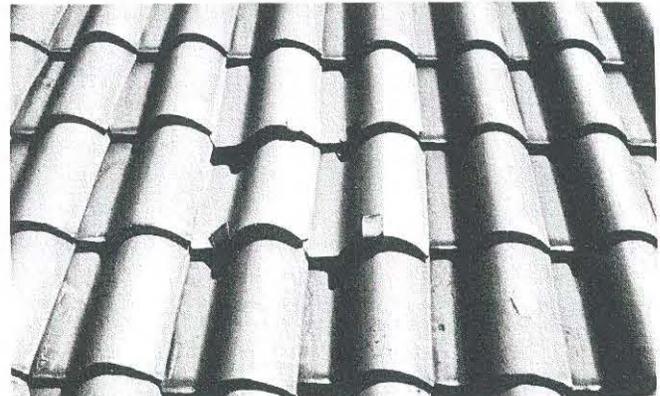
Repairs on this pantile roof were made with new tiles held in place with metal hangers. (Main Building, Ellis Island, New York)

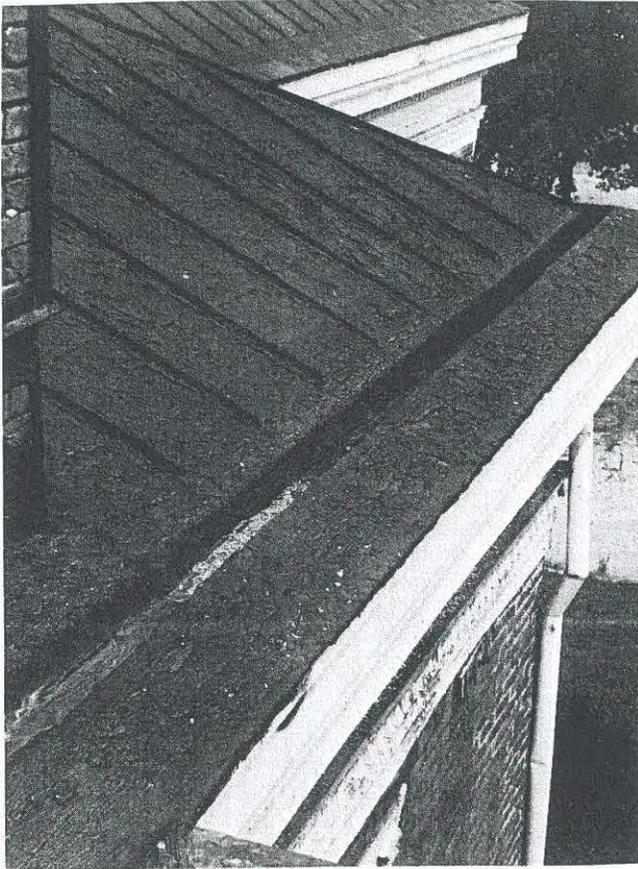
Repeated repair with asphalt, which cracks as it hardens, has created a blistered surface on this sheet-metal roof and built-in gutter, which will retain water. Repairs could be made by carefully heating and scraping the surface clean, repairing the holes in the metal with a flexible mastic compound or a metal patch, and coating the surface with a fibre paint. (Roane County Courthouse, Kingston, Tennessee, photo courtesy of Building Conservation Technology, Inc.)

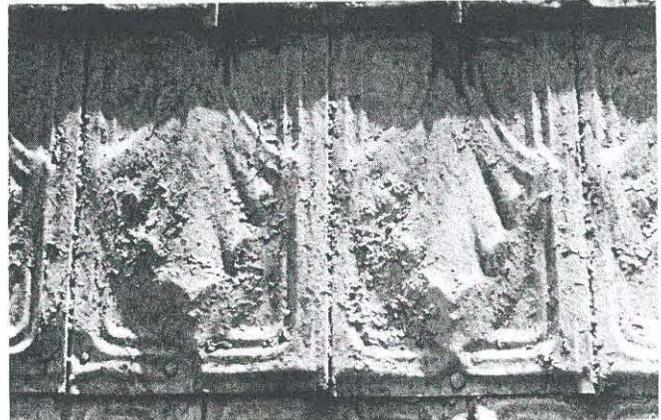
Tin shingles, commonly embossed to imitate wood or tile, or with a decorative design, were popular as an inexpensive, textured roofing material. These shingles $8\frac{3}{8}$ inch by $12\frac{1}{2}$ inch on the exposed surface) were designed with interlocking edges, but they have been repaired by surface nailing, which may cause future leakage. (Ballard House, Yorktown, Virginia, photo by Gordie Whittington, National Park Service)

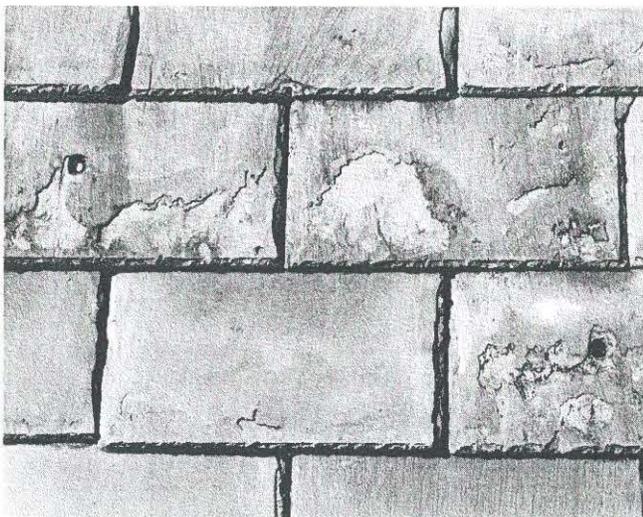
This detail shows slate delamination caused by a combination of weathering and pollution. In addition, the slates have eroded around the repair nails, incorrectly placed in the exposed surface of the slates. (Lower Pontalba Building, New Orleans, photo courtesy of Building Conservation Technology, Inc.)

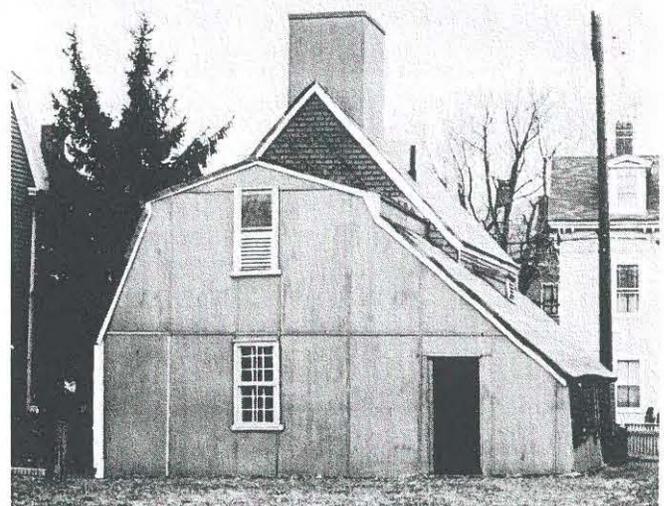
Temporary stabilization or “mothballing” with materials such as plywood and building paper can protect the roof of a project until it can be properly repaired or replaced. (Narbonne House, Salem, Massachusetts)
