NATIONAL CITY
**GRANGER
MUSIC HALL**

RELOCATION FEASIBILITY STUDY

November
7, 2017

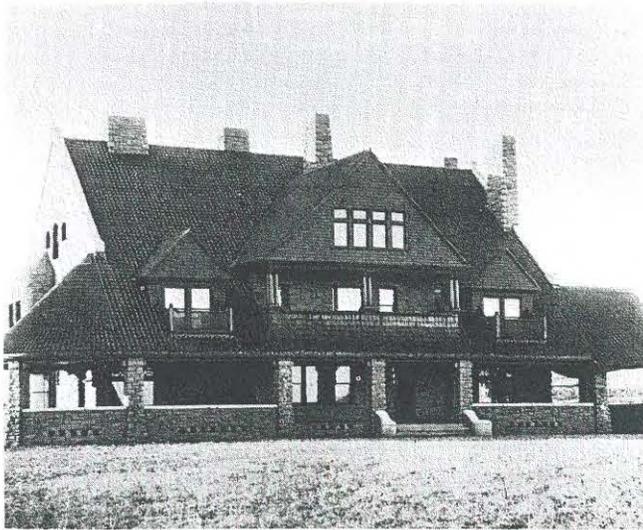
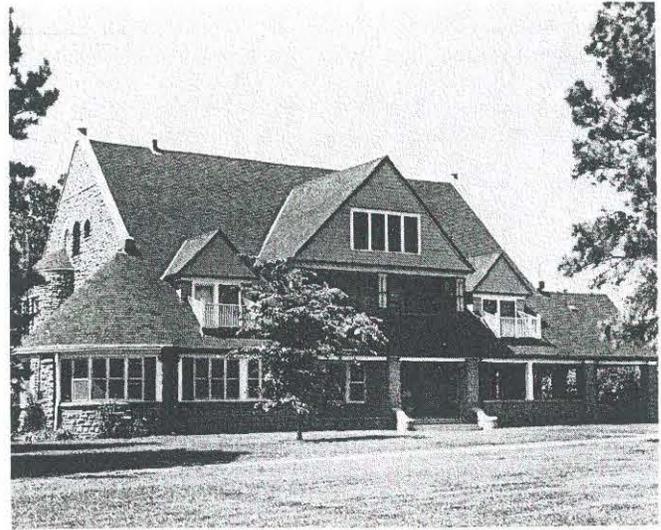
These two views of the same house demonstrate how the use of a substitute material can drastically affect the overall character of a structure. The textural interest of the original tile roof was lost with the use of asphalt shingles. Recent preservation efforts are replacing the tile roof. (Frank House, Kearney, Nebraska, photo courtesy of the Nebraska State Historical Society, Lincoln, Nebraska)

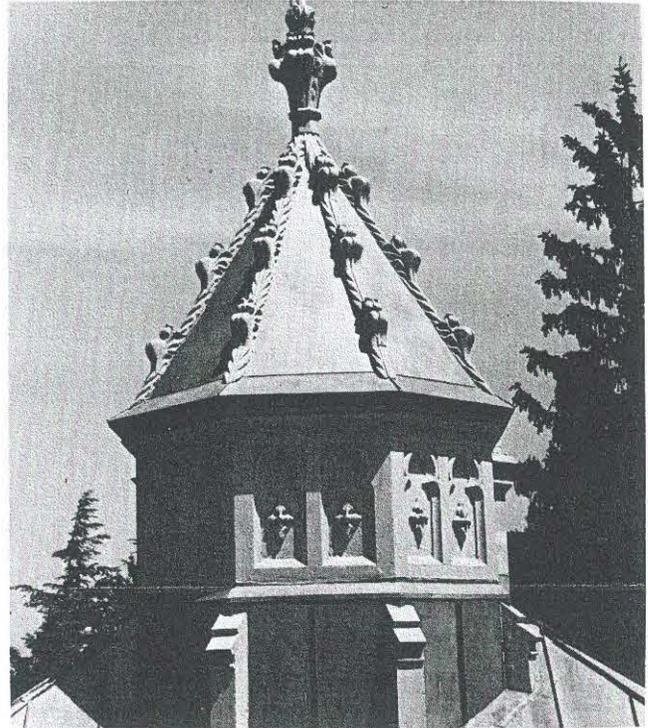
Decorative features such as cupolas require extra maintenance. The flashing is carefully detailed to promote run-off, and the wooden ribbing must be kept well-painted. This roof surface, which was originally tin plate, has been replaced with lead-coated copper for maintenance purposes. (Lyndhurst, Tarrytown, New York, photo courtesy of the National Trust for Historic Preservation)

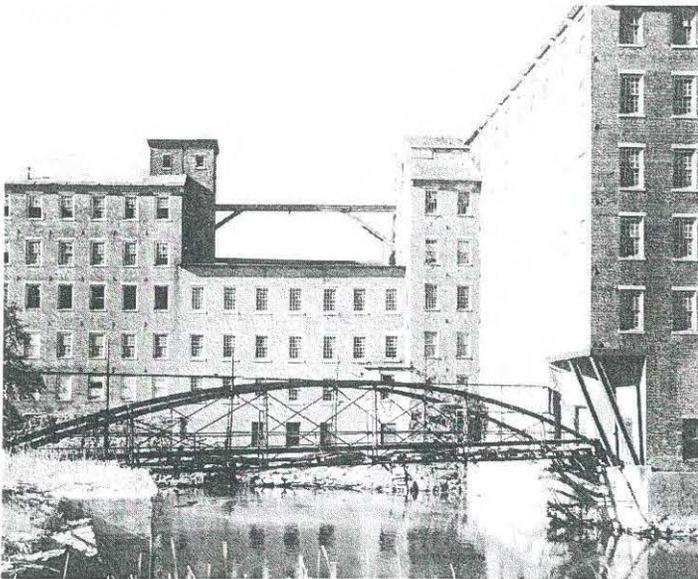
Figure 1. Windows are frequently important visual focal points, especially on simple facades such as this mill building. Replacement of the multi-pane windows here with larger panes could dramatically change the appearance of the building. The areas of missing windows convey the impression of such a change. Photo: John T. Lowe

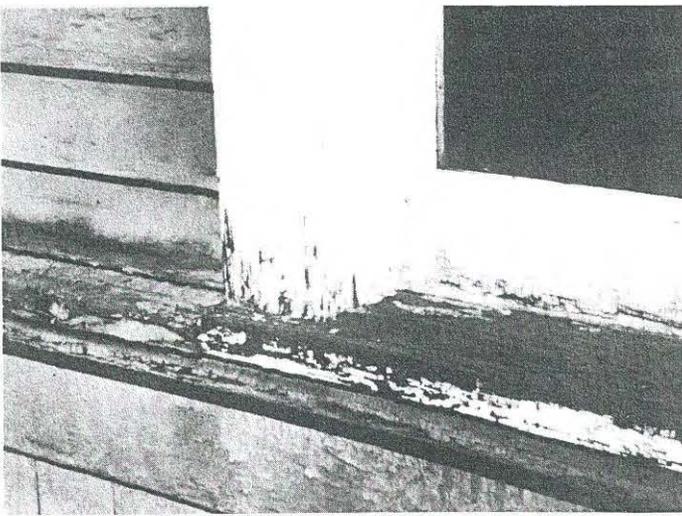
Figure 3. Deterioration of poorly maintained windows usually begins on horizontal surfaces and at joints where water can collect and saturate the wood. The problem areas are clearly indicated by paint failure due to moisture. Photo: Baird M. Smith, AIA

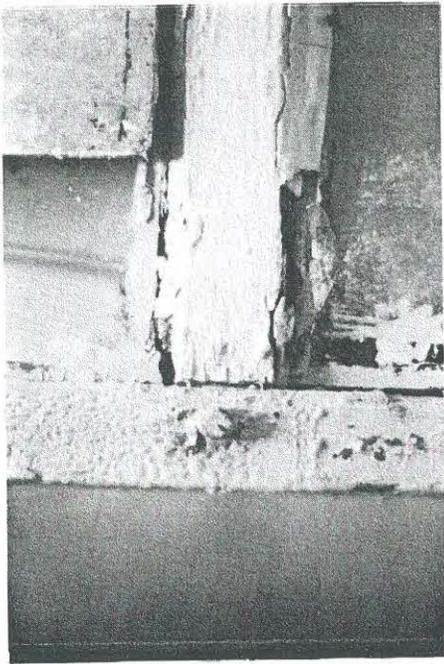
Figure 4a. The following series of photographs of the repair of a historic double-hung window use a unit which is structurally sound but has many layers of paint, some cracked and missing putty, slight separation at the joints, broken sash cords, and one cracked pane. Photo: John H. Myers

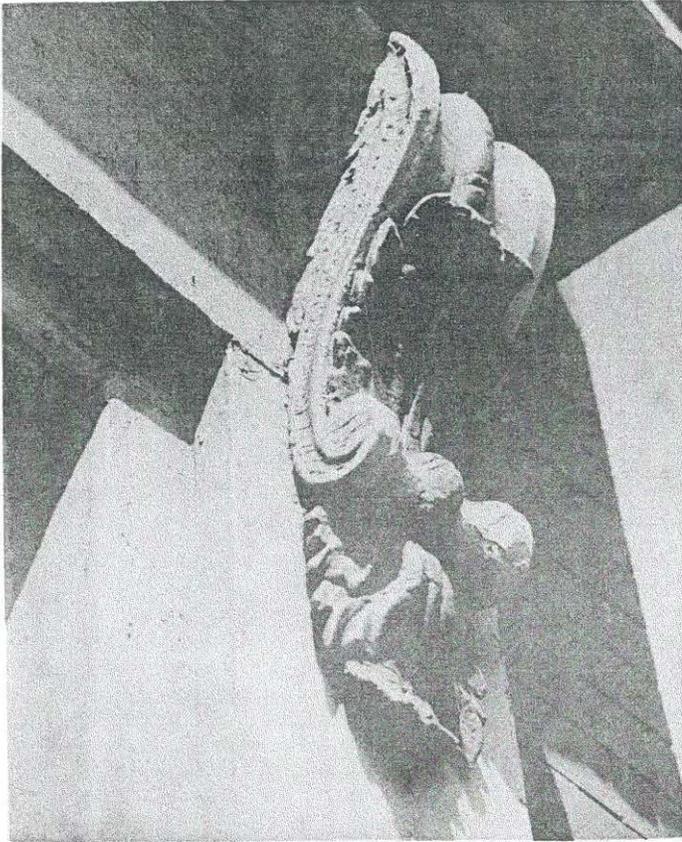
Fig. 1 Excessive paint build-up on architectural details such as this ornamental bracket does not in itself justify total paint removal. If paint is cracked and peeling down to bare wood, however, it should be removed using the gentlest means possible. Photo: David W. Look, AIA.

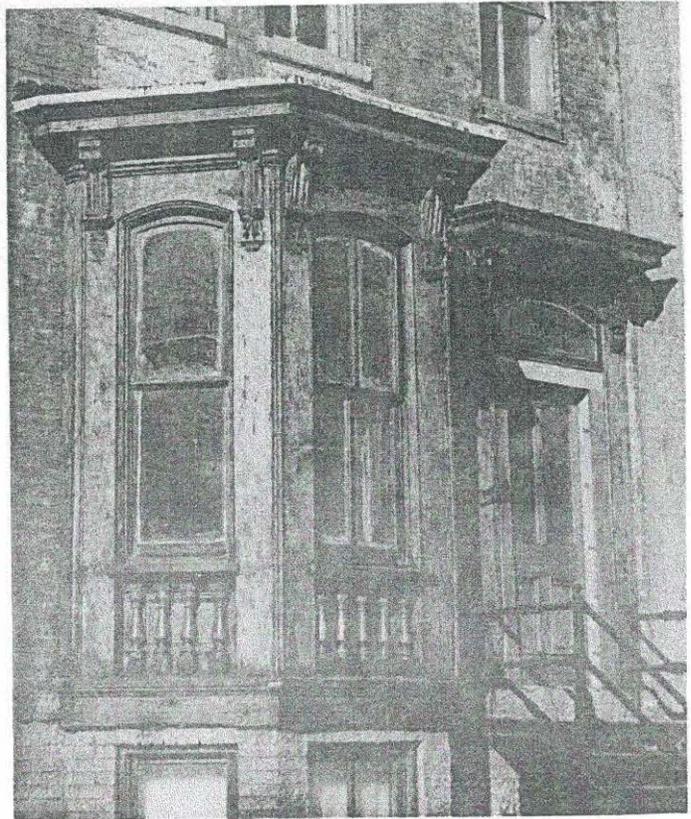
Fig. 2 A traditionally painted bay window has been stripped to bare wood, then varnished. In addition to being historically inaccurate, the varnish will break down faster as a result of the sun's ultraviolet rays than would primer and finish coats of paint. Photo: David W. Look, AIA.

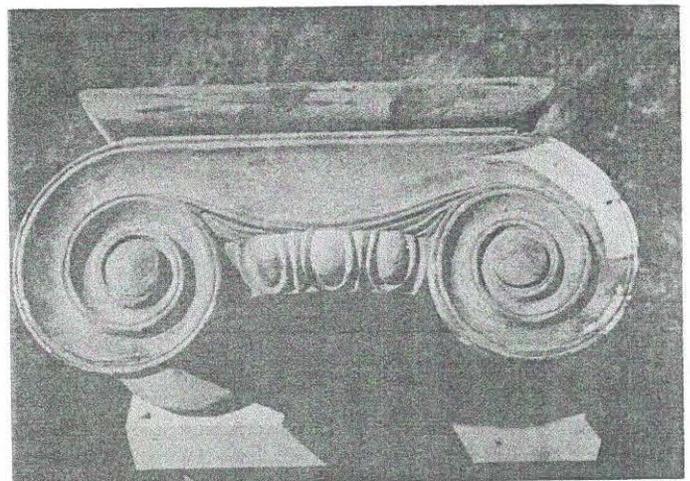
Fig. 3 If damage to parts of a wooden element is severe, new sections of wood will need to be pieced-in. When such piecing is required, paint on the adjacent woodwork should be removed so that the old and new woods will make a smooth profile when joined. After repainting, the repair should be virtually impossible to detect. Photo: Morgan W. Phillips.

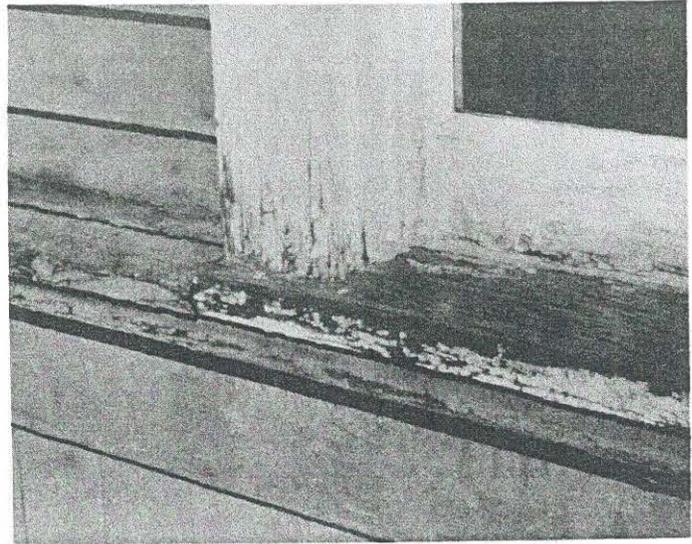
Fig. 4 Paint films wear unevenly depending on exposure and location. Exterior locations which are susceptible to accelerated deterioration are horizontal surfaces such as window sills. These and similar areas will require repainting more often than less vulnerable surfaces. In the case of this window sill where paint has peeled off and adjacent areas have cracked and alligatored, the paint should be **totally removed**. Prior to repainting, any weathered wood should be rejuvenated using a solution of 3 cups exterior varnish, 1 oz. paraffin wax, and mineral spirits/paint thinner/or turpentine to make 1 gallon. Liberal brush application should be made. This formula was tested over a 20-year period by the U.S. Department of Agriculture's Forest Products Laboratory and proved to be just as effective as water-repellent preservatives containing pentachlorophenol. After the surface has thoroughly dried (2-3 days of warm weather), the treated surface can be painted. A high quality oil-base primer followed by two top coats of a semi-gloss oil-enamel or latex-enamel paint is recommended. Photo: Baird M. Smith, AIA.

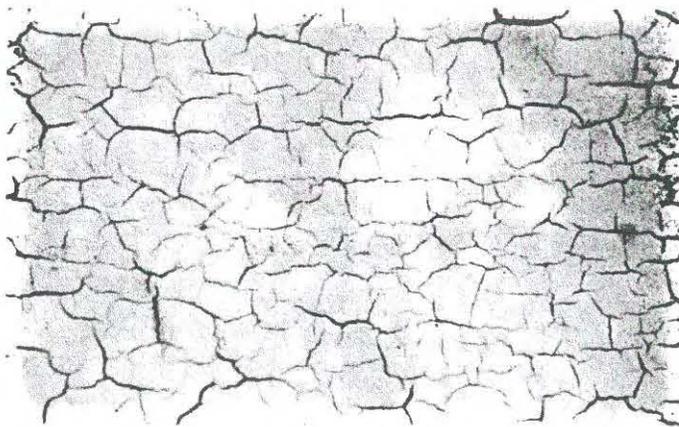
Crazing—fine, jagged interconnected breaks in the top layer of paint—results when paint that is several layers thick becomes excessively hard and brittle with age and is consequently no longer able to expand and contract with the wood in response to changes in temperature and humidity (see figure 5). As the wood swells, the bond between paint layers is broken and hairline cracks appear. Although somewhat more difficult to detect as opposed to other more obvious paint problems, it is well worth the time to scrutinize all surfaces for crazing. If not corrected, exterior moisture will enter the crazed surface, resulting in further swelling of the wood and, eventually, deep cracking and alligating, a Class III condition which requires total paint removal.

Fig. 5 Crazing—or surface cracking—is an exterior surface condition which can be successfully treated by sanding and painting. Photo: Courtesy, National Decorating Products Association.

Crazing can be treated by hand or mechanically sanding the surface, then repainting. Although the hairline cracks may tend to show through the new paint, the surface will be protected against exterior moisture penetration.

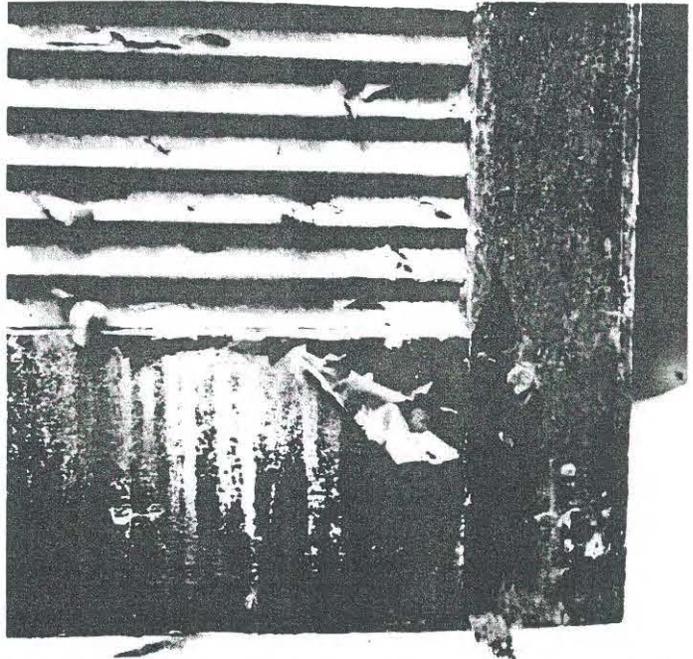
Another common cause of intercoat peeling is incompatibility between paint types (see figure 6). For example, if oil paint is applied over latex paint, peeling of the top

Fig. 6 This is an example of intercoat peeling. A latex top coat was applied directly over old oil paint and, as a result, the latex paint was unable to adhere. If latex is being used over oil, an oil-base primer should be applied first. Although much of the peeling latex paint can be scraped off, in this case, the best solution may be to chemically dip strip the entire shutter to remove all of the paint down to bare wood, rinse thoroughly, then repaint. Photo: Mary L. Oehrlein, AIA.

Where peeling was the result of using incompatible paints, the peeling top coat should be scraped and hand or mechanically sanded. Application of a high quality oil type exterior primer will provide a surface over which either an oil or a latex topcoat can be successfully used.

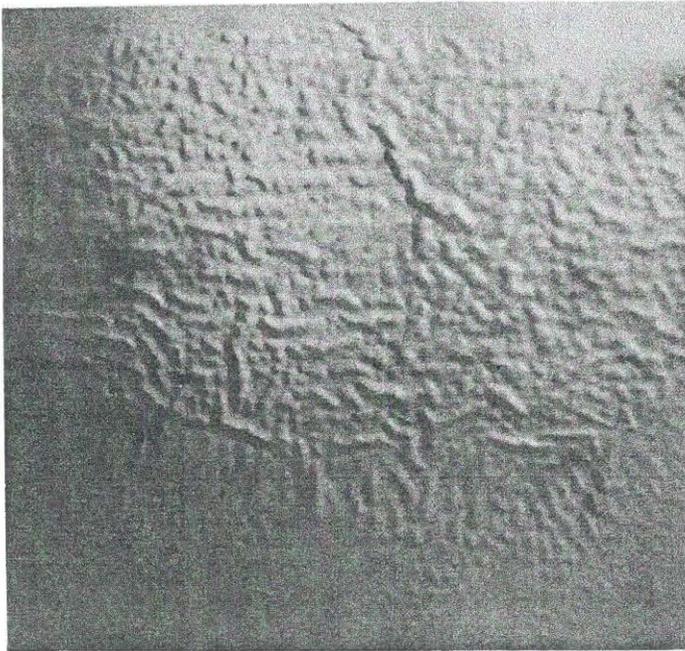
Another error in application that can easily be avoided is wrinkling (see figure 7). This occurs when the top layer of paint dries before the layer underneath. The top layer of paint actually moves as the paint underneath (a primer, for example) is drying. Specific causes of wrinkling include: (1) applying paint too thick; (2) applying a second coat before the first one dries; (3) inadequate brushing out; and (4) painting in temperatures higher than recommended by the manufacturer.

Fig. 7 Wrinkled layers can generally be removed by scraping and sanding as opposed to total paint removal. Following manufacturers' application instructions is the best way to avoid this surface condition. Photo: Courtesy, National Decorating Products Association.

The wrinkled layer can be removed by scraping followed by hand or mechanical sanding to provide as even a surface as possible, then repainted following manufacturer's application instructions.

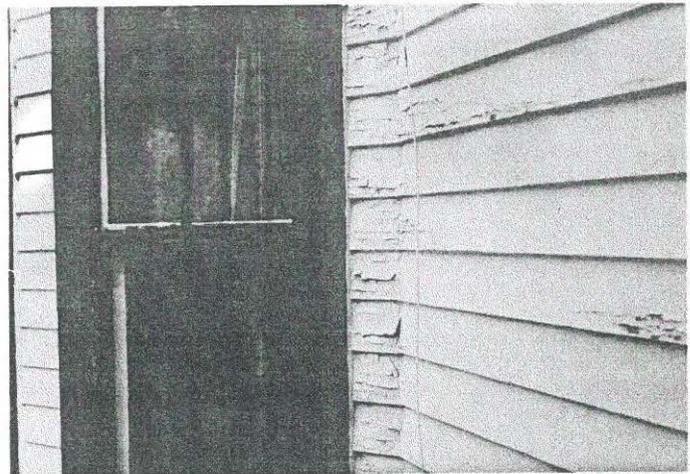
film, thus impairing adhesion (see figure 8). Generally beginning as blisters, cracking and peeling occur as moisture causes the wood to swell, breaking the adhesion of the bottom layer.

Fig. 8 Peeling to bare wood—one of the most common types of paint failure—is usually caused by an interior or exterior moisture problem. Photo: Anne E. Grimmer.

There is no sense in repainting before dealing with the moisture problems because new paint will simply fail. Therefore, the first step in treating peeling is to locate and remove the source or sources of the moisture, not only because moisture will jeopardize the protective coating of paint but because, if left unattended, it can ultimately cause permanent damage to the wood. Excess interior moisture should be removed from the building through installation of exhaust fans and vents. Exterior moisture should be eliminated by correcting the following conditions prior to repainting: faulty flashing; leaking gutters; defective roof shingles; cracks and holes in siding and trim; deteriorated caulking in joints and seams; and shrubbery growing too close to painted wood. After the moisture problems have been solved, the wood must be permitted to dry out thoroughly. The damaged paint can then be scraped off with a putty knife, hand or mechanically sanded, primed, and repainted.

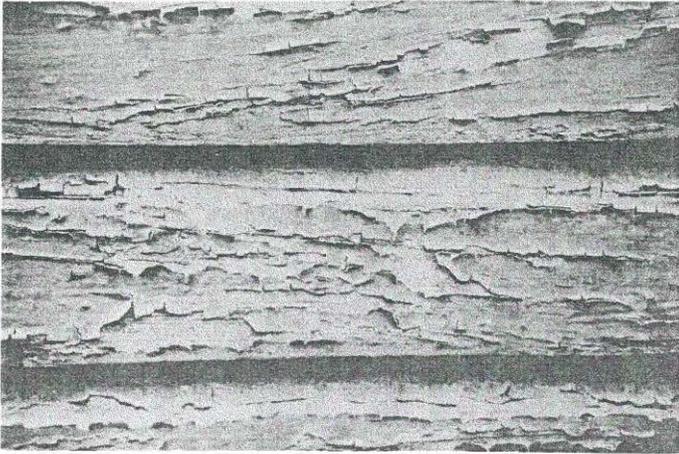
Cracking and alligatoring are advanced stages of crazing (see figure 9). Once the bond between layers has been broken due to intercoat paint failure, exterior moisture is able to penetrate the surface cracks, causing the wood to swell and deeper cracking to take place. This process continues until cracking, which forms parallel to grain, extends to bare wood. Ultimately, the cracking becomes an overall pattern of horizontal and vertical breaks in the paint layers that looks like reptile skin; hence, "alligatoring." In advanced stages of cracking and alligatoring, the surfaces will also flake badly.

Fig. 9 Cracking, alligatoring, and flaking are evidence of long-term neglect of painted surfaces. The remaining paint on the clapboard shown here can be removed with an electric heat plate and wide-bladed scraper. In addition, unsound wood should be replaced and moisture problems corrected before primer and top coats of paint are applied. Photo: David W. Look, AIA.

If cracking and alligatoring are present only in the top layers they can probably be scraped, hand or mechanically sanded to the next sound layer, then repainted. However, if cracking and/or alligatoring have progressed to

bare wood and the paint has begun to flake, it will need to be totally removed. Methods include scraping or paint removal with the electric heat plate, electric heat gun, or chemical strippers, depending on the particular area involved. Bare wood should be primed within 48 hours, then repainted.

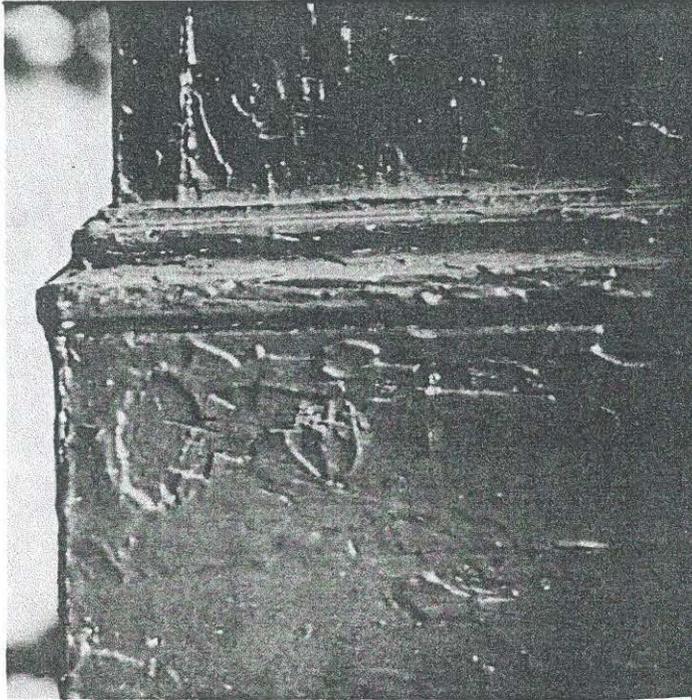
Fig. 10 An excellent example of inadequate scraping before repainting, the problems here are far more than cosmetic. This improperly prepared surface will permit moisture to get behind the paint film which, in turn, will result in chipping and peeling. Photo: Baird M. Smith, AIA.

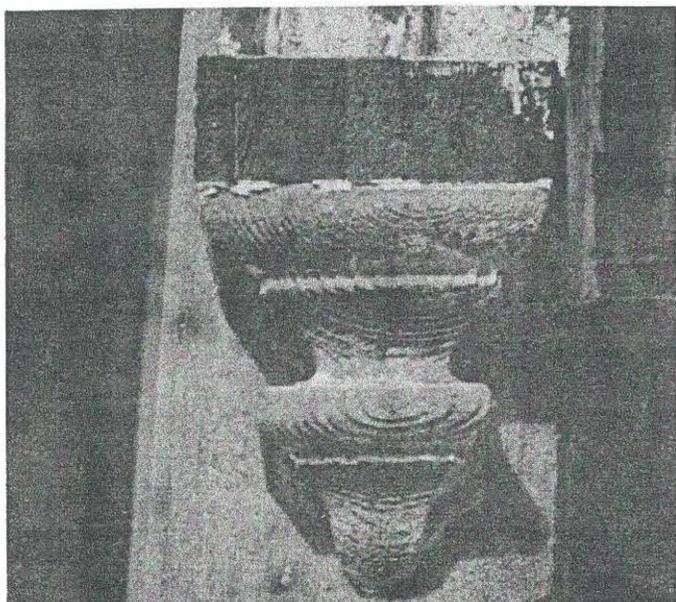
Fig. 12 Sandblasting has permanently damaged this ornamental bracket. Even paint will not be able to hide the deep erosion of the wood. Photo: David W. Look, AIA.

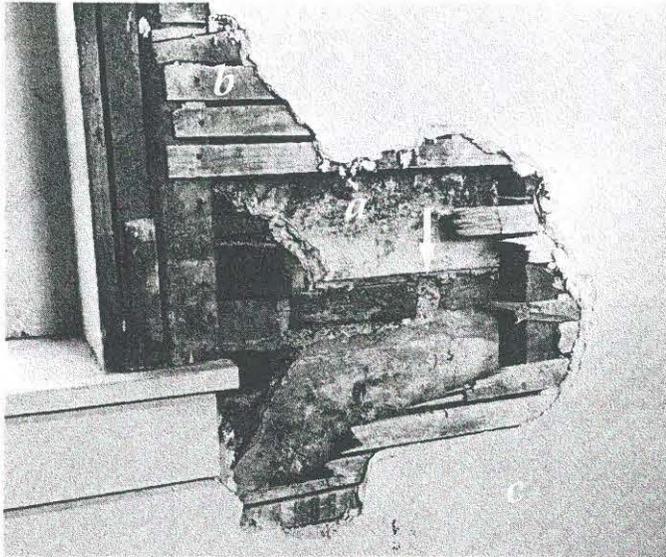
Fig. 2. A hole in the wall of a 1760s Custom House in Chestertown, Maryland illustrates the evolution of the room. (a) The original plaster was applied directly to an exterior masonry wall and the chairrail (missing here, see arrow) was in place before the wet plaster was applied to the wall. Sometime later when the interior was modified, the masonry was furred out. Machine-sawn wood lath (b) was nailed to the furring strips and (c) new three-coat plaster was applied. Photo: Maryland Historical Trust.

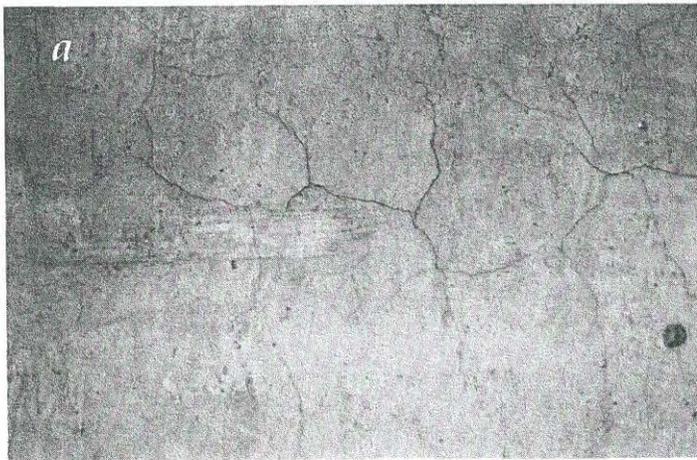
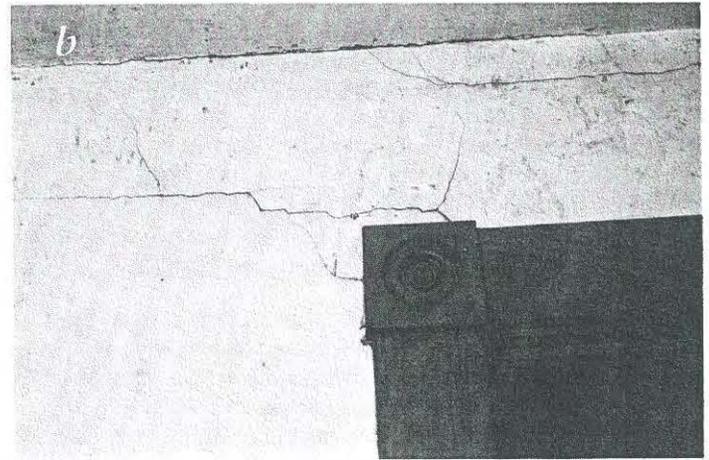
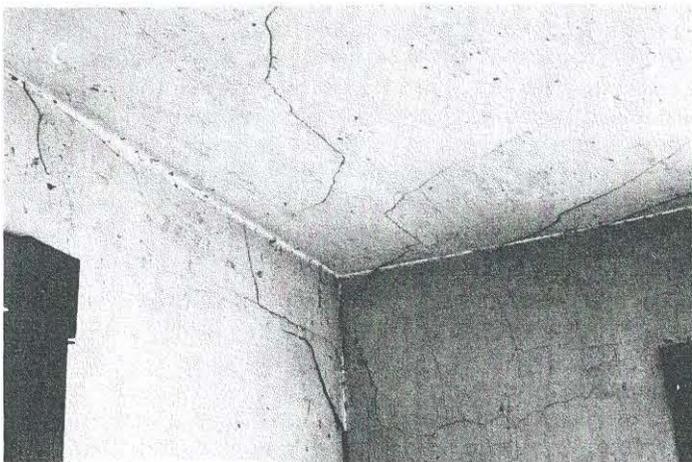
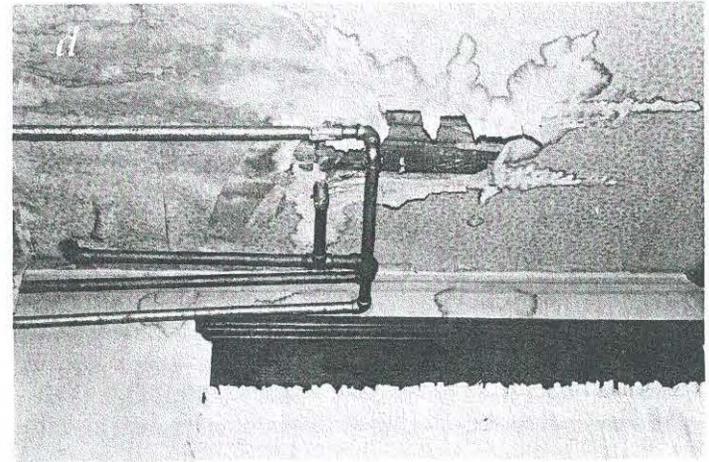
Fig. 7 (a) to (d). A series of photographs taken in different rooms of an early 20th century house in West Virginia reveal a variety of plaster wall surface problems, most of which can easily be remedied through sensitive repair: Hairline cracks (a) in an otherwise sound wall can be filled with joint compound or patching plaster. The wall can also be canvassed or wallpapered. Stress cracks (b) in plaster over a kitchen door frame can be repaired using fiberglass mesh tape and joint compound. Settlement cracks (c) in a bedroom can be similarly repaired. The dark crack at the juncture between walls, however, may be a structural crack and should be investigated for its underlying cause. Moisture damage (d) from leaking plumbing on the second floor has damaged both wallpaper and plaster in the dining room. After fixing the leaking pipes, the wall covering and rotted plaster will need to be replaced and any holes repaired. Photos: Kay Weeks.

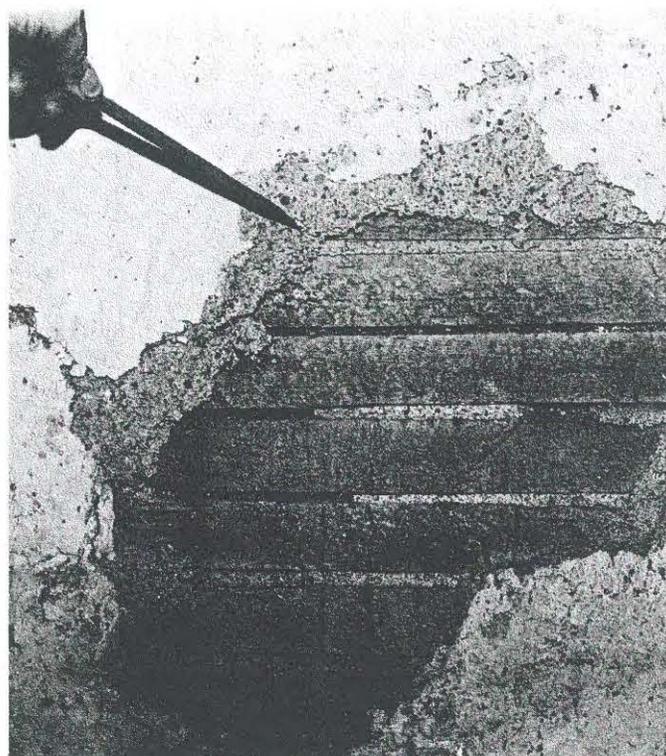
Fig. 8. Too much aggregate (sand) and not enough cementing material (lime or gypsum) in the base coat has made this plaster surface weak and crumbly. Besides losing its key with the lath, the layers are disintegrating. It will most likely need to be totally removed and replaced with all new plaster. Photo: Marylee MacDonald.

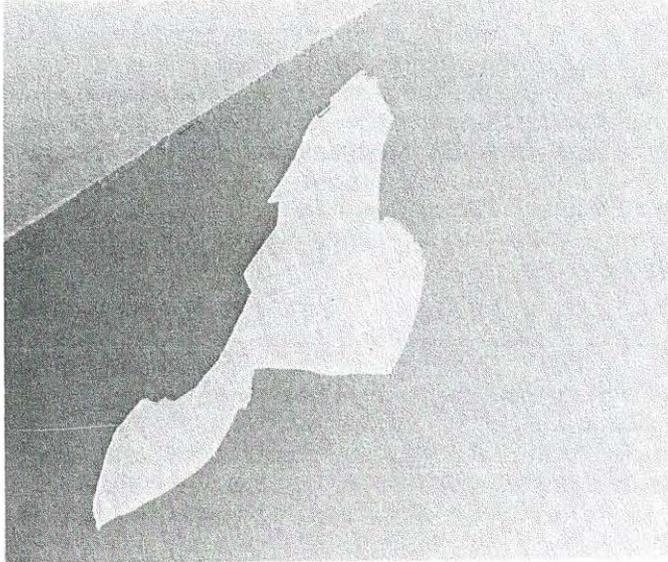
Fig. 9. The smooth-troweled lime finish coat has delaminated from the brown coat underneath. This is another repair that can be undertaken without further loss of the historic plaster. Photo: Marylee MacDonald.

Sometimes the finish coat of plaster comes loose from the base coat (Fig. 9). In making this type of repair, the plasterer paints a liquid plaster-bonding agent onto the areas of base-coat plaster that will be replastered with a new lime finish coat. A homeowner wishing to repair small areas of delaminated finish coat can use the methods described in **Patching Materials**.

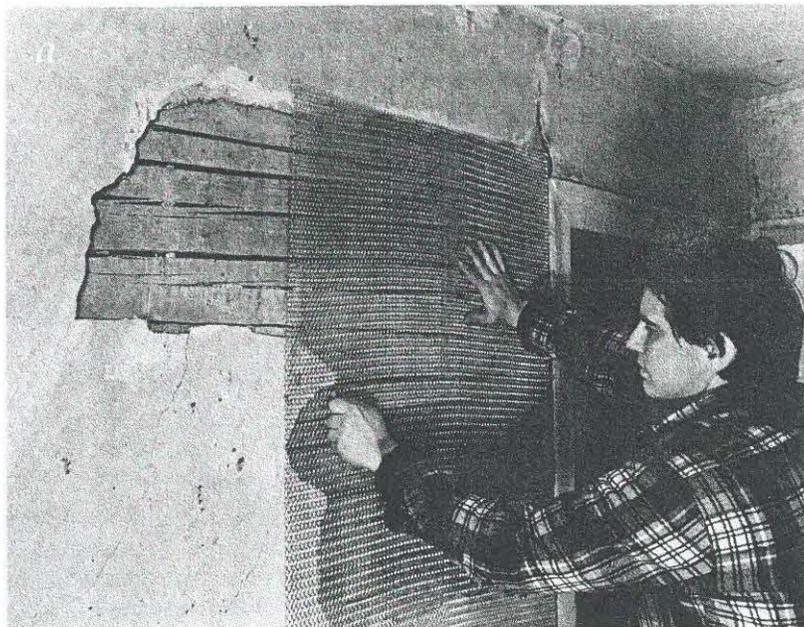
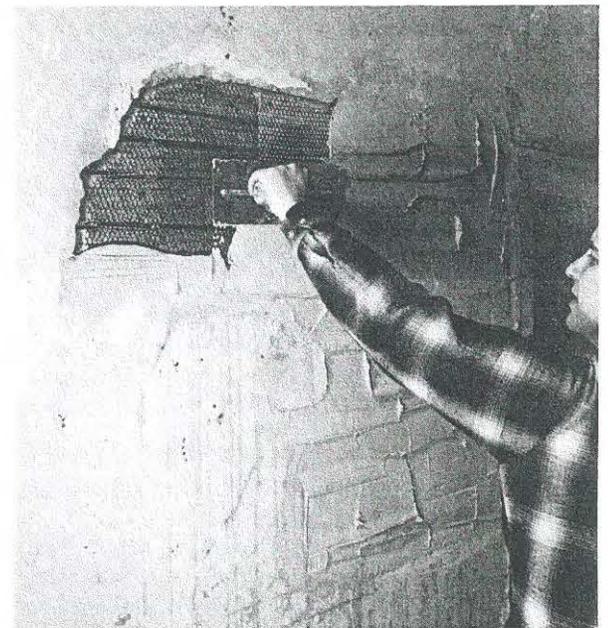
Fig. 10 (a) and (b). In this New Hampshire residence dating from the 1790s, the original plaster was a single coat of lime, sand, and horsehair applied over split lath. A one-coat repair, in this case, is appropriate. To the left: a flat sheet of galvanized expanded metal lath is placed over the patch area and an outline marked with a large soft lumber crayon. The metal lath is then cut to fit the hole and nailed to the lath. To the right: the edges of the original plaster and wood lath beneath have been thoroughly soaked with water. A steel trowel is used to apply the plaster in large, rough strokes. Finally, it will be scraped and smoothed off. Because only one coat of plaster is used, without a finish coat, a clean butt-joint is made with the original plaster. Photos: John Leeke.

For small holes (less than 4 inches in diameter) that involve loss of the brown and finish coats, the repair is made in two applications. First, a layer of basecoat plaster is troweled in place and scraped back below the level of the existing plaster. When the base coat has set but not dried, more plaster is applied to create a smooth, level surface. One-coat patching is not generally recommended by plasterers because it tends to produce concave surfaces that show up when the work is painted. Of course, if the lath only had one coat of plaster originally, then a one-coat patch is appropriate (Fig. 10).

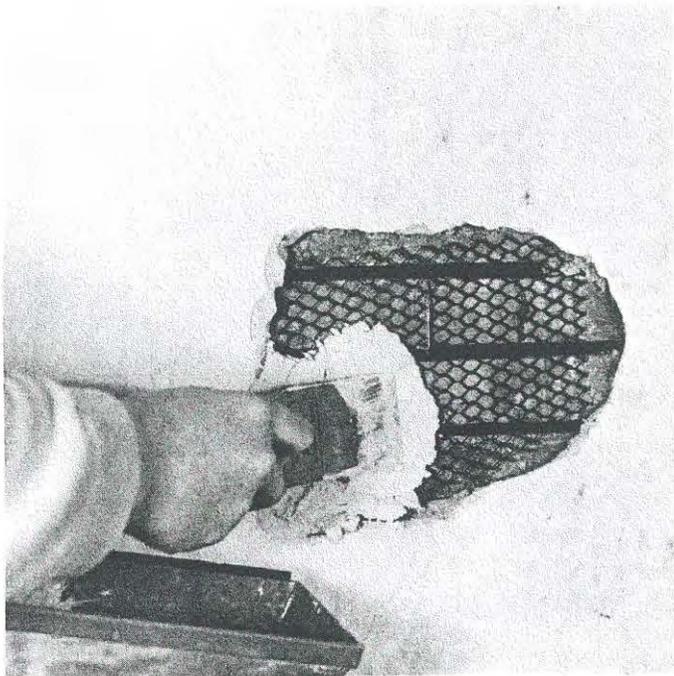
Fig. 11. Repairs are being made to the historic plaster in an early 20th century residence in Tennessee. A fairly sizeable hole in three-coat plaster extends to the wood lath. Expanded metal lath has been cut to fit the hole, then attached to the wood lath with a tie-wire. Two ready-mix gypsum base coats are in the process of being applied. After they set, the finish coat will be smooth-troweled gauged lime to match the existing wall. Photo: Walter Jowers.

For larger holes where all three coats of plaster are damaged or missing down to the wood lath, plasterers generally proceed along these lines. First, all the old plaster is cleaned out and any loose lath is re-nailed. Next, a water mist is sprayed on the old lath to keep it from twisting when the new, wet plaster is applied, or better still, a bonding agent is used. To provide more reliable keying and to strengthen the patch, expanded metal lath (diamond mesh) should be attached to the wood lath with tie wires or nailed over the wood lath with lath nails (Fig. 11). The plaster is then applied in three layers over the metal lath, lapping each new layer of plaster over the old plaster so that old and new are evenly joined. This stepping is recommended to produce a strong, invisible patch (Fig. 12). Also, if a patch is made in a plaster wall that is slightly wavy, the contour of the patch should be made to conform to the irregularities of the existing work. A flat patch will stand out from the rest of the wall.

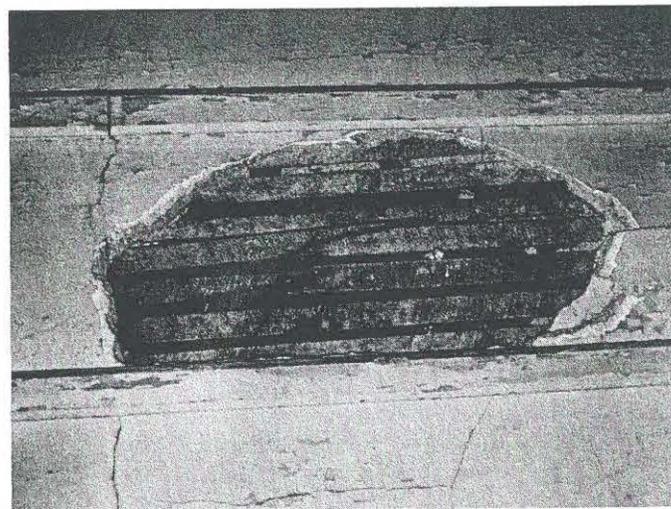
Hairline cracks and holes may be unsightly, but when portions of the ceiling come loose, a more serious problem exists (Fig. 13). The keys holding the plaster to the ceiling have probably broken. First, the plaster around the loose plaster should be examined. Keys may have deteriorated because of a localized moisture problem, poor quality plaster, or structural overloading; yet, the surrounding system may be intact. If the areas surrounding the loose area are in reasonably good condition, the loose plaster can be reattached to the lath using flat-head wood screws and plaster washers (Fig. 14). To patch a hole in the ceiling plaster, metal lath is fastened over the wood lath; then the hole is filled with successive layers of plaster, as described above.

Fig. 13. This beaded ceiling in one of the bedrooms of the 1847 Lockwood House, Harpers Ferry, West Virginia, is missing portions of plaster due to broken keys. This is attributable, in part, to deterioration of the wood lath. Photo: Kaye Ellen Simonson.

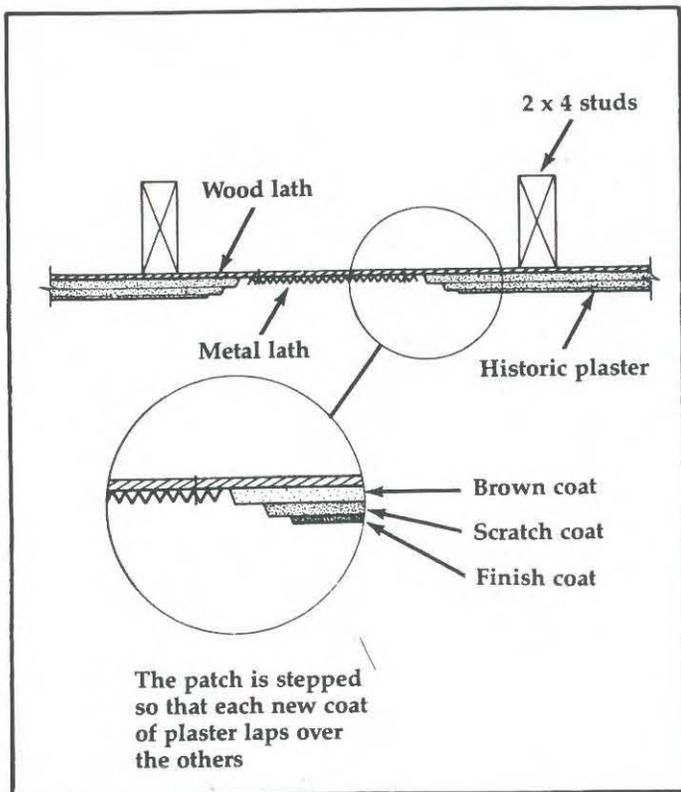
Fig. 12. This explains how a hole in historic plaster is repaired over the existing wood lath. First, metal lath is secured over the wood lath with a tie wire, then the new plaster is applied in three layers, "stepped" so that each new coat overlaps the old plaster to create a good adhesive bond. Drawing: Kaye Ellen Simonson.

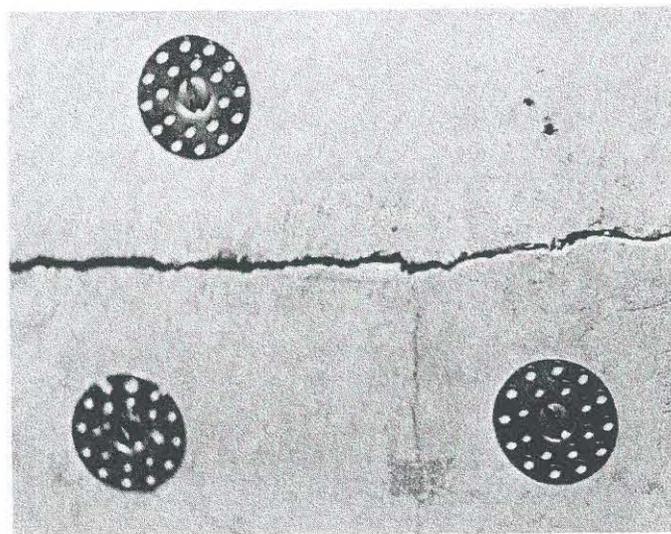
Fig. 14. In a late 18th century house in Massachusetts, flat-head wood screws and plaster washers were used to reattach loose ceiling plaster to the wood lath. After the crack is covered with fiberglass mesh tape, both the taped crack and the plaster washers will be skim-coated with a patching material. Photo: John Obed Curtis.

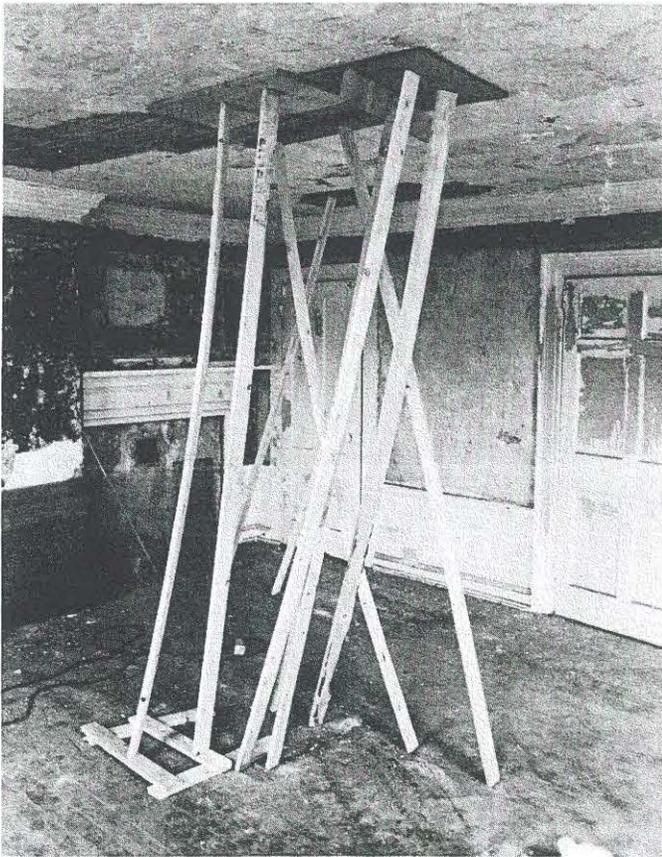
Fig. 15. When ceiling repairs are made with wet plaster or with an injected adhesive mixture, the old loose plaster must be supported with a plywood brace until re-keying is complete. Photo: John Leeke.

Loose, damaged plaster can also be re-keyed when the goal is to conserve decorative surfaces or wallpaper. Large areas of ceilings and walls can be saved. This method requires the assistance of a skilled conservator—it is not a repair technique used by most plasterers. The conservator injects an acrylic adhesive mixture through holes drilled in the face of the plaster (or through the lath from behind, when accessible). The loose plaster is held firm with plywood bracing until the adhesive bonding mixture sets. When complete, gaps between the plaster and lath are filled, and the loose plaster is secure (Fig. 15).

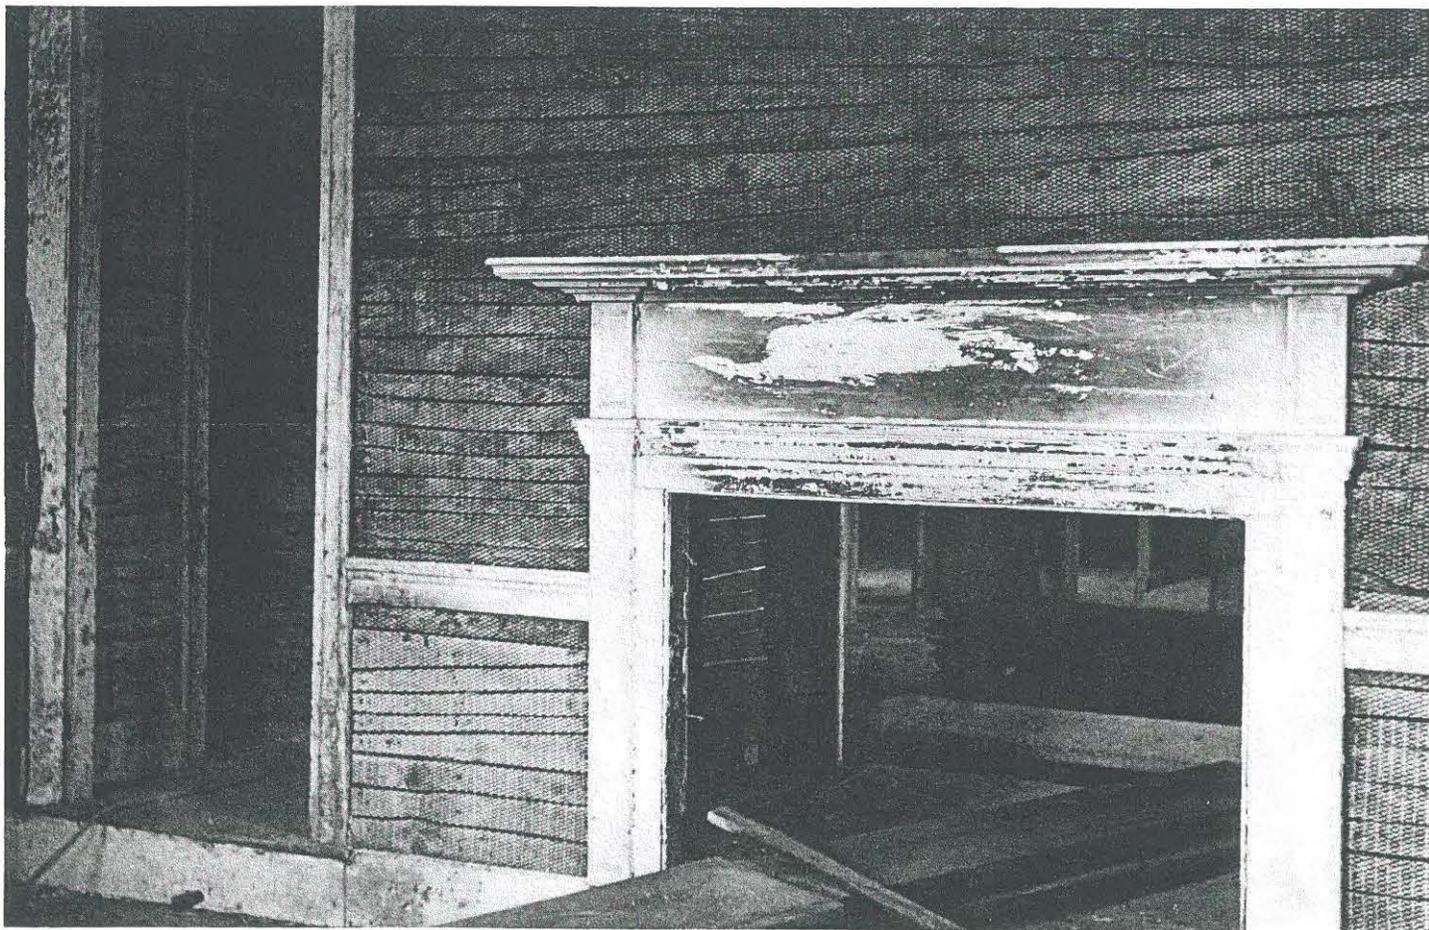
Fig. 16. In the restoration of a ca. 1830s house in Maine, split-board lath has been covered with expanded metal lath in preparation for new coats of plaster. This method permits the early lath to be saved while the metal lath, with its superior keying, serves as reinforcement. Photo: National Park Service files.

many of these problems can be avoided and the historic lath can be retained (Fig. 16). The ceiling should still be sprayed unless a vapor barrier is placed behind the metal lath.

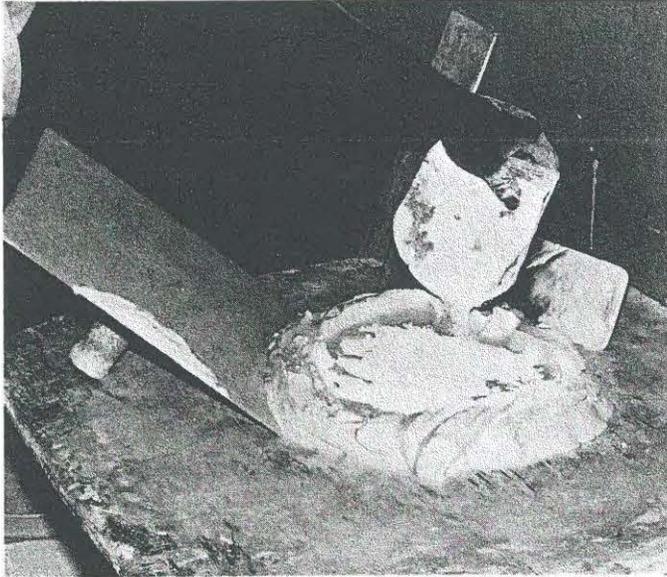
Fig. 17. This contemporary plasterer is mixing a lime finish coat in much the same way as America's earlier artisans. The ring consists of lime putty; the white powder inside is gauging plaster. After the mixture is blended, a steel trowel will be used to apply it. It should be noted that a traditional lime finish coat can be applied over a veneer plaster base coat to approximate the look of historic plaster walls and ceilings. Photo: Marylee MacDonald.

The system uses gypsum-core panels that are the same size as drywall (4x8 feet), and specially made for veneer plaster. They can be installed over furring channels to masonry walls or over old wood lath walls and ceilings. Known most commonly as "blueboard," the panels are covered with a special paper compatible with veneer plaster. Joints between the 4-foot wide sheets are taped with fiberglass mesh, which is bedded in the veneer plaster. After the tape is bedded, a thin, 1/16-inch coat of high-strength veneer plaster is applied to the entire wall surface. A second veneer layer can be used as the "finish" coat, or the veneer plaster can be covered with a gauged lime finish-coat—the same coat that covers ordinary plaster (Fig. 17).
